The Western Front in the Backyard
The Archaeological Survey of Camp Howze, Texas

A Thesis

Anthropology

August, 2014

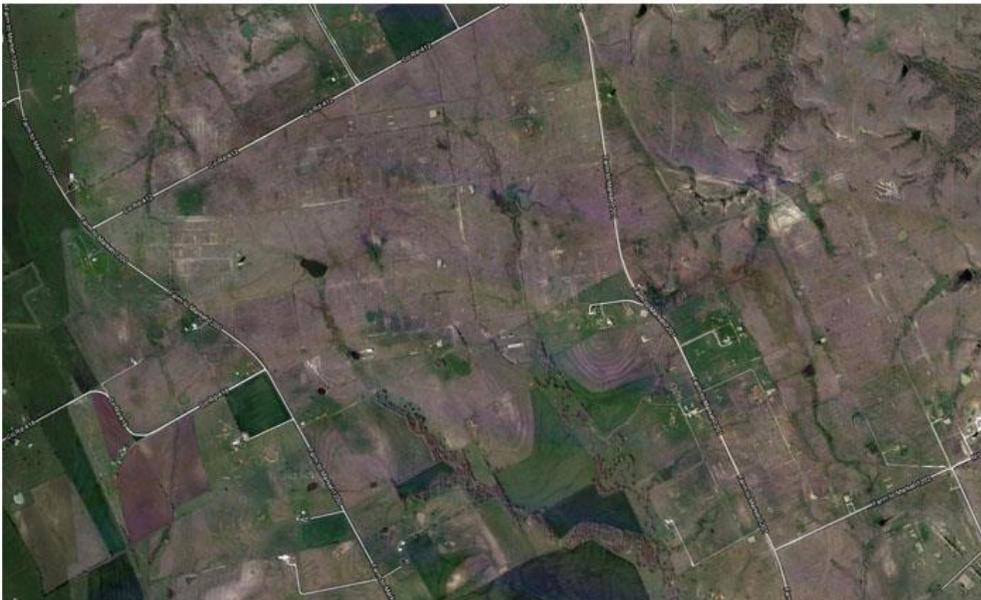
Figure 7 - The Original Plan Map for Camp Howze's Main Compound, Contrasted With a 2012 Satellite View

Four surveying trips were made to Camp Howze. These surveys were guided by historical information and documents, most notably maps of the base obtained from the local libraries and from the national archives (Figure 7 shows the original Camp Howze plan map contrasted with modern satellite imagery, showing the footprint of the camp visible). We were also able to utilize certain camp maps and official records that had been

The section identified on maps as the “Prison Camp Hospital” shows little evidence of the structures that would have defined the POW area, especially compared to the number of remaining structures in the main hospital complex. The western corner was incorporated into part of Farm to Market Road 1200, as shown in Figure 44. Very little disturbance from the POW extension remains, save for part of a cement foundation in the south corner. The area was not an original planned construction as indicated on the base plan map (Figure 7), this suggests that the area was set up using temporary structures.

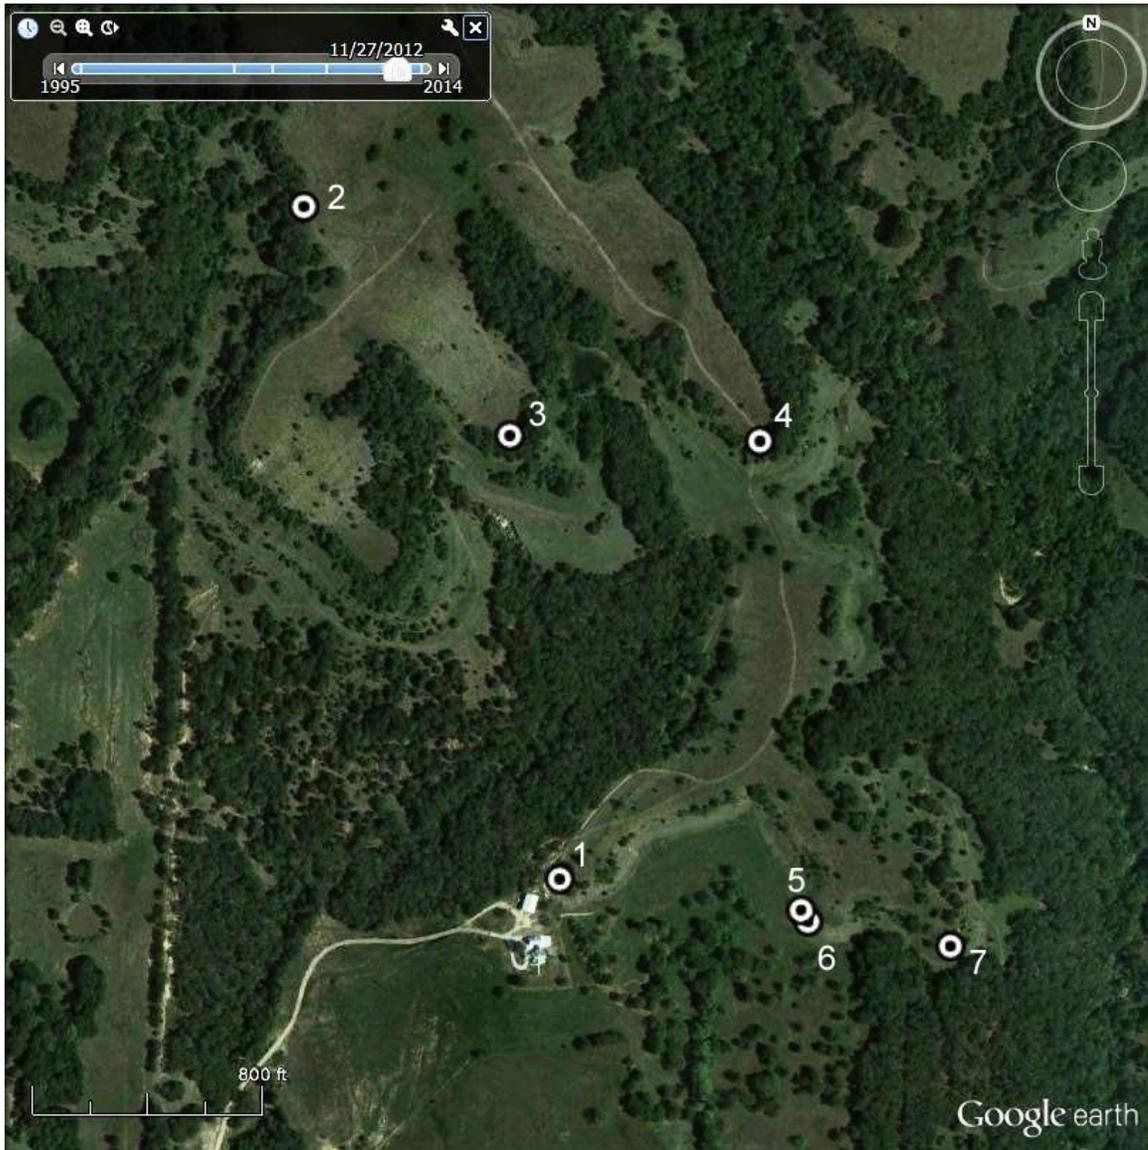
Figure 9 - The Western Artillery Range Feature Locations

The initial survey was conducted on a former artillery range located near County Road 411, just east of Marysville (Figure 9). The US Army referred to the area as the “East Marysville Area”, and the artillery ranges were in a designated “fortified area” (Kaden 1943). The land is now private property and is mostly undeveloped, though the owner uses the land for deer hunting.

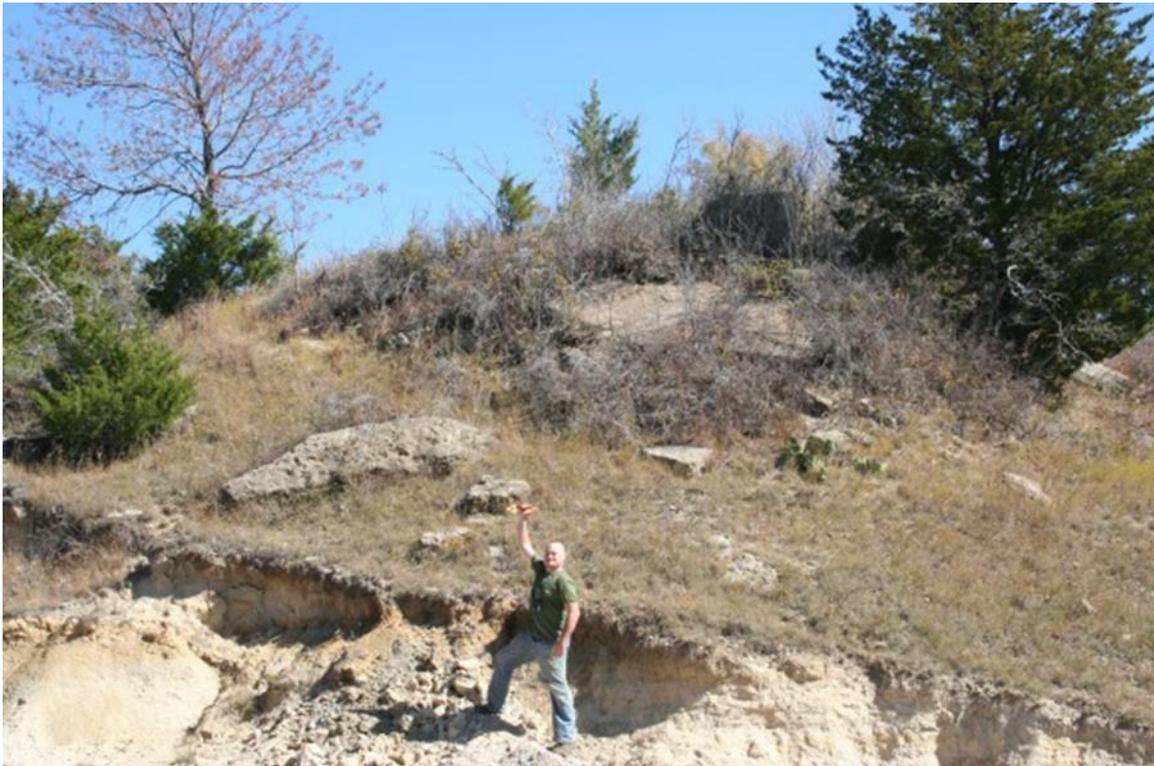
Figure 10 - Feature 1

Feature 1 is a concrete structure located on a hill overlooking the landowner's house (Figure 10). It is the largest of the artillery range features in size, though most of the structure is broken up and has fallen down the hill. The one standing wall is 493 cm (16 feet) long, and 15.24 cm (6 inches) thick. The material is shaped concrete containing metal rebar. A rubble push pile (designated Feature 1A) sits at the top of the hill, measuring 310cm (10 feet 2 inches) by 288 cm (9 feet 5 inches). The landowner believes this structure was the launching platform for the artillery, or possibly the observation bunker (Hess, personal communication).

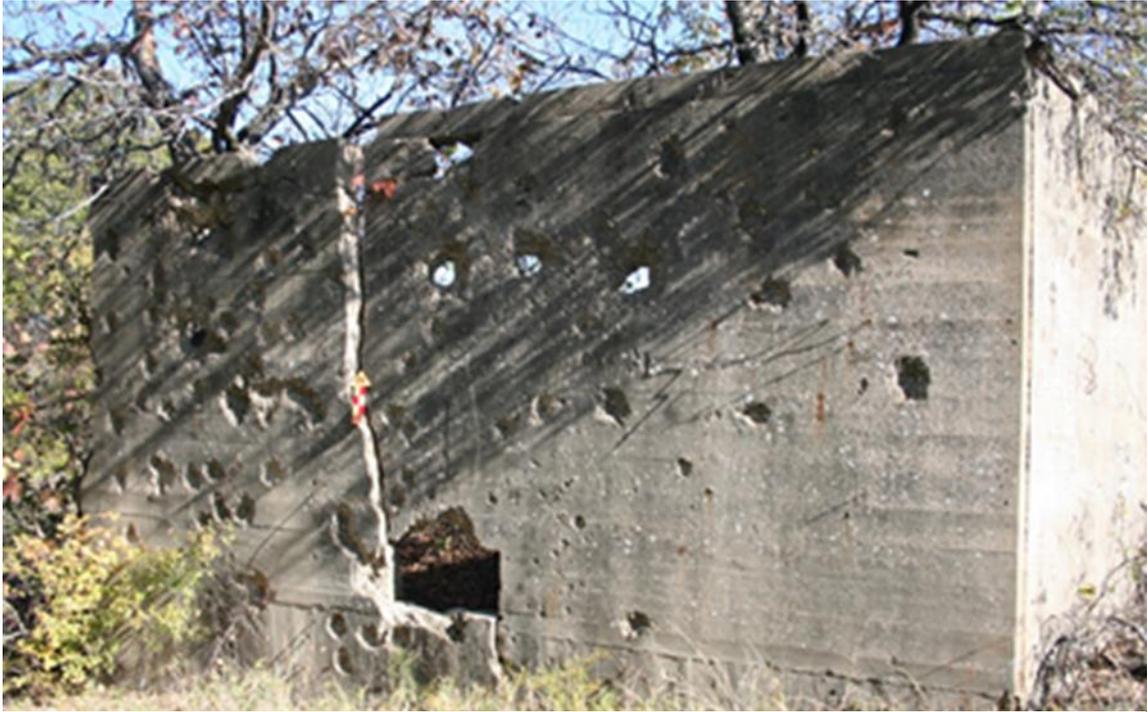
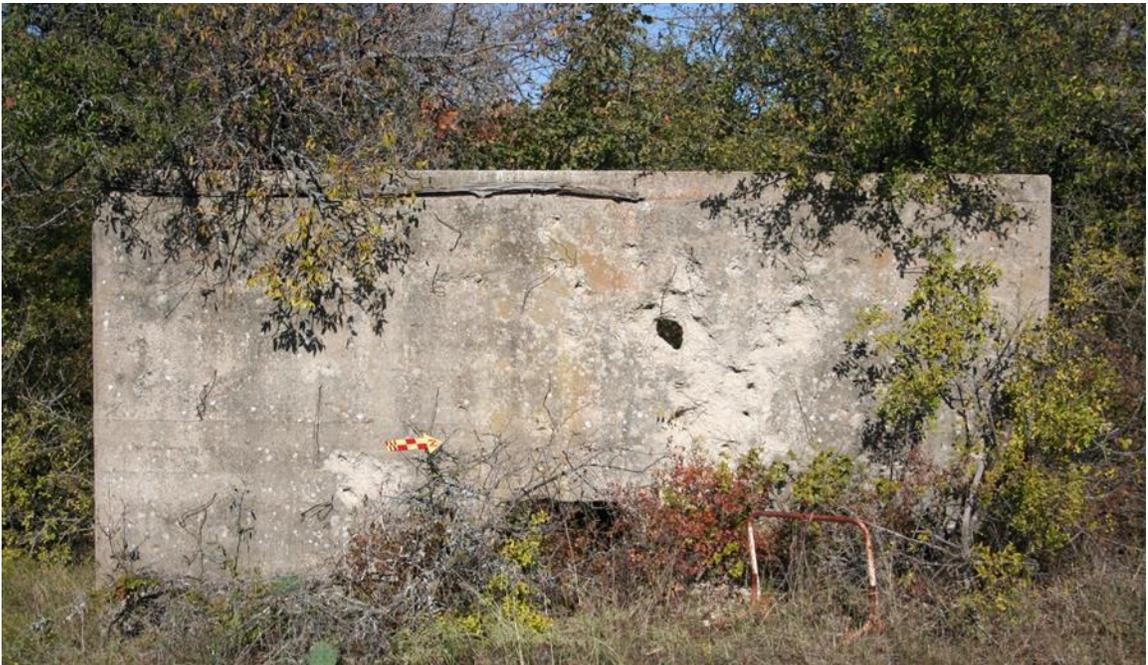
Feature 2 is a concrete structure located on the western side of the target field north of Feature 1. The west wall has broken off and collapsed. A window along the base of the structure facing the target field suggests that this was a sighting bunker for forward observers to practice calling in artillery strikes (Figures 11 – 12).

Southeast wall width	4.87 m (15 ft 11 in)
Southwest wall width	4.85 m (15 ft 10 in)
Northwest wall width (collapsed)	4.90 m (16 ft)
South corner height	2.52 m (8 ft 3 in)
East corner height	2.03 m (6 ft 8 in)

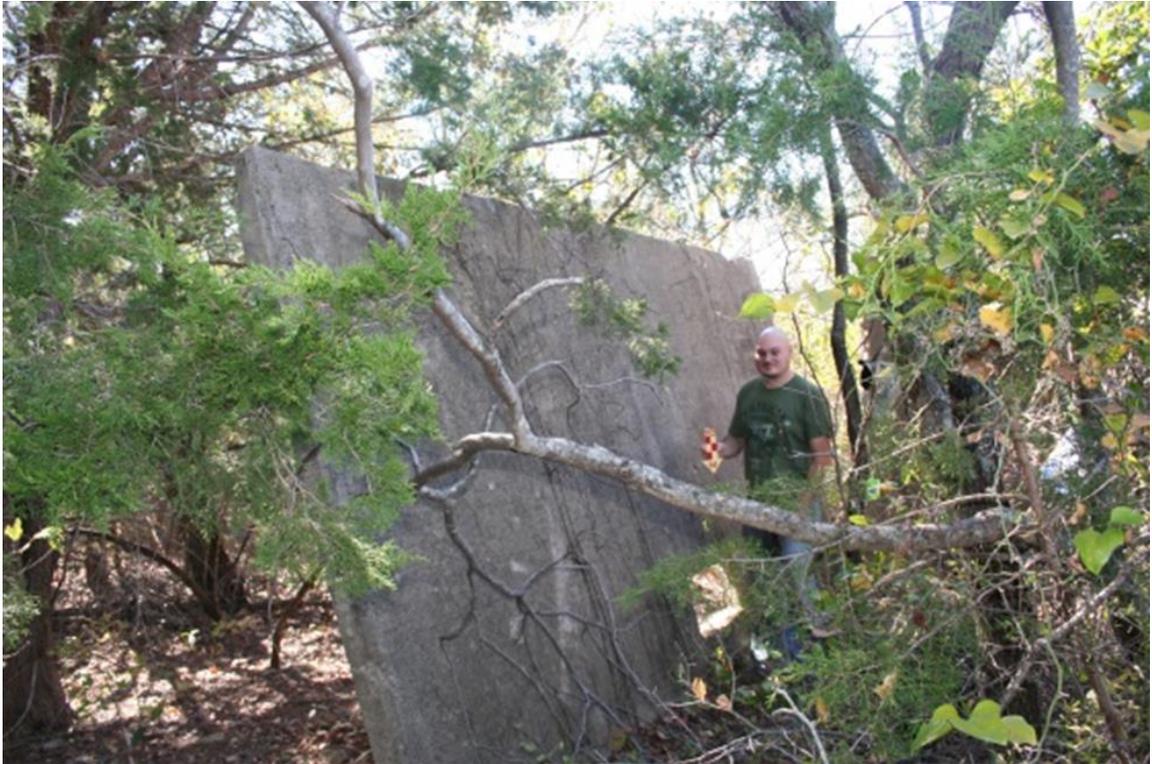
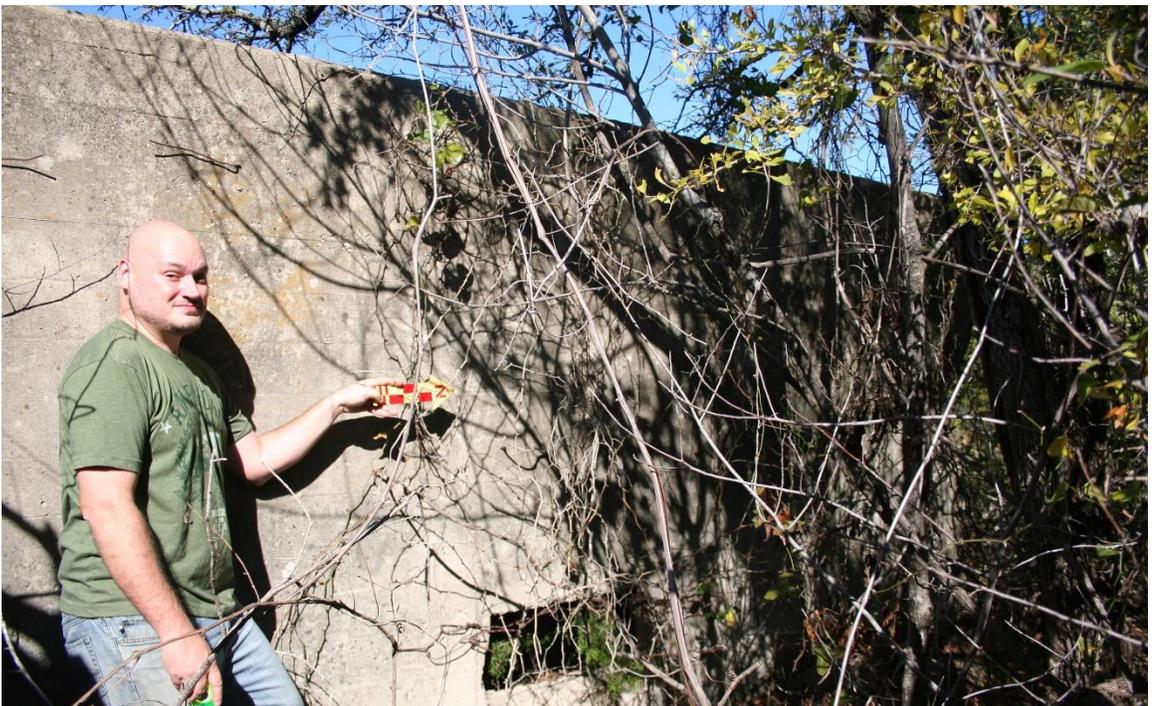
Feature 3 compliments Feature 2 and is located on the eastern side of the same field. Low windows appear on the eastern and southern walls, measuring 31cm (1 foot) high, and 61 cm (2 feet) across on the inside, but 91.5 cm (3 feet) on the outside. The south and west walls are broken off of the structure, and lean inward (Figures 13 – 14).

East wall width	4.75 m (15 ft 7 in)
East wall height	2.36 m (7 ft 9 in)
South wall width	4.6 m (15 ft 1 in)
South wall height	2.27 m (7 ft 5 in)
West Wall height	2.2 m (7 ft 2 in)

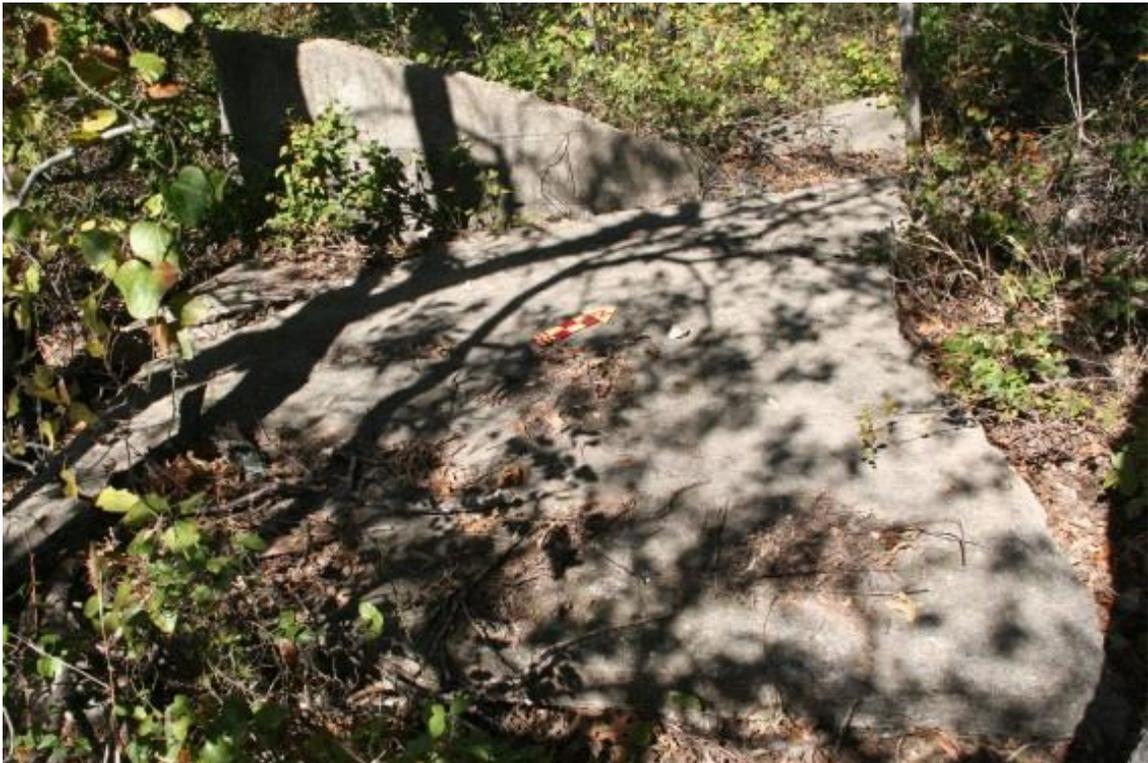
Figure 15 - Feature 4

Feature 4 is a fallen bunker to the northeast of the target field. Only one small piece of a wall remains standing, and its original purpose is not known (Figure 15). The wall is on the west side, with 18 cm (7 inches) thick prefab walls, and is 89 cm (2 feet 11 inches) at the tallest point, with a base width of 198 cm (6 feet 6 inches).

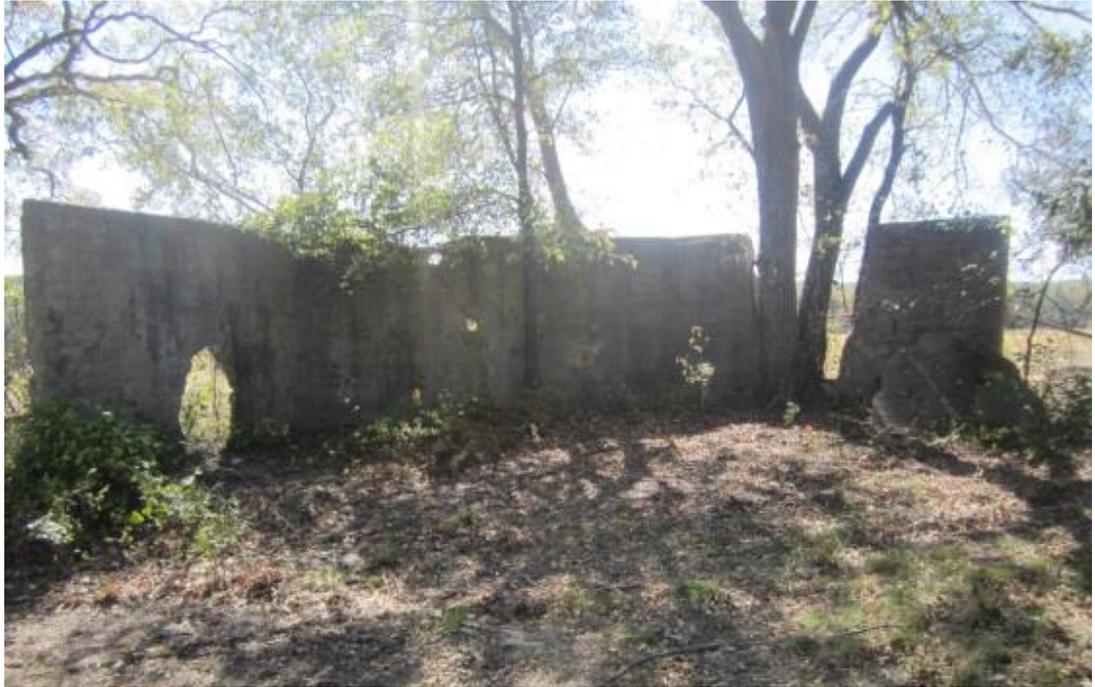
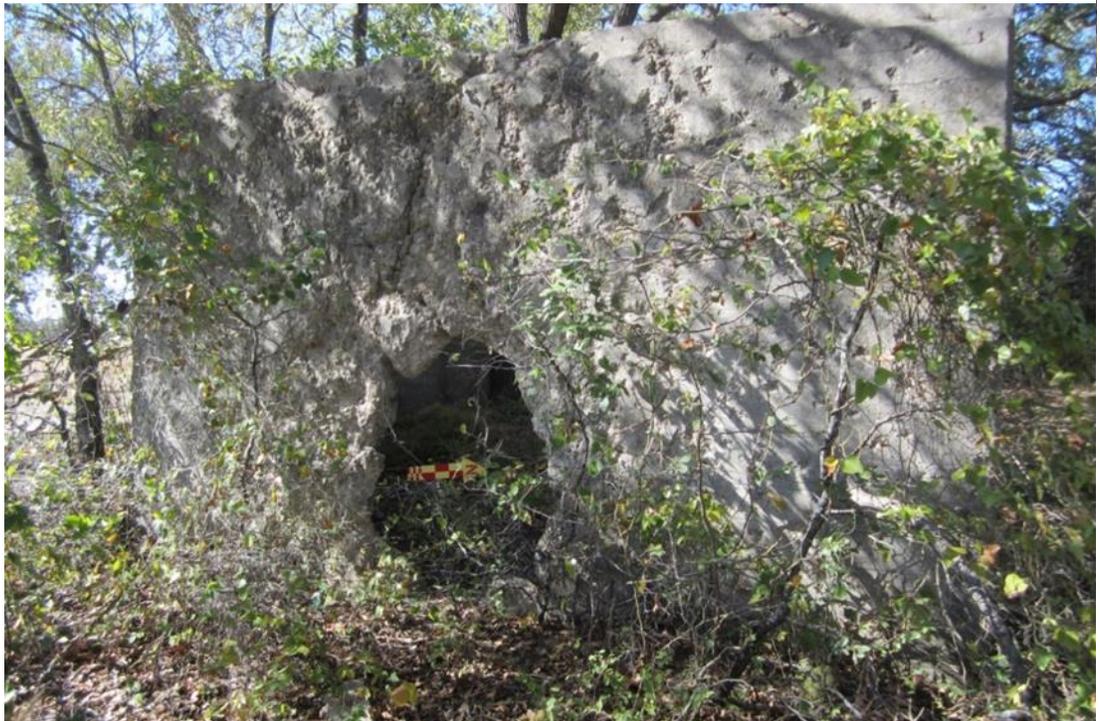
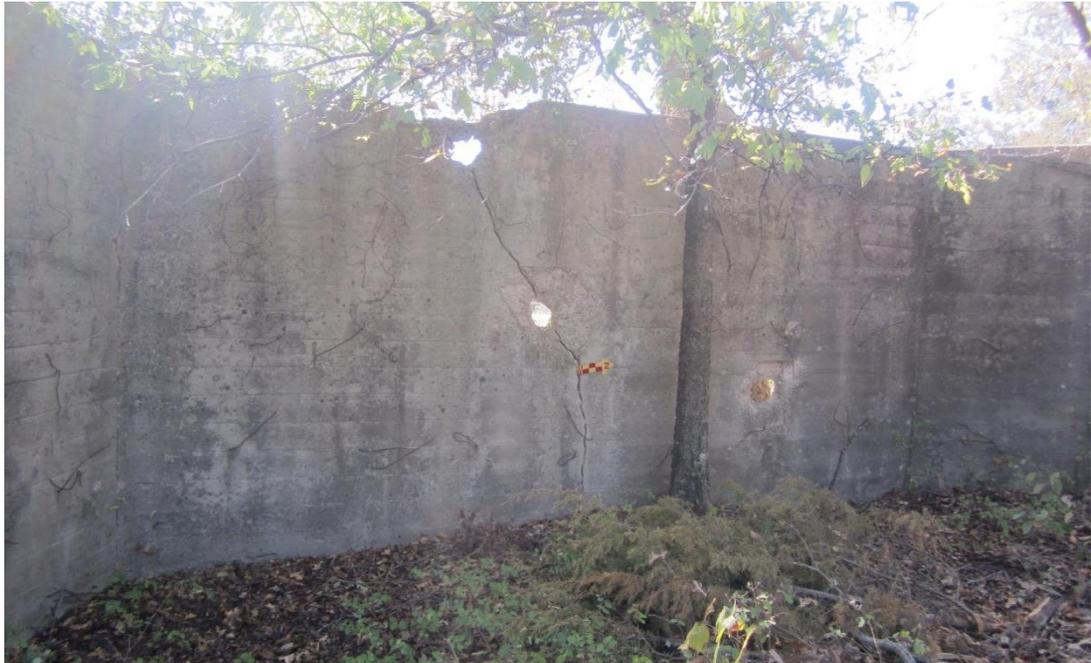
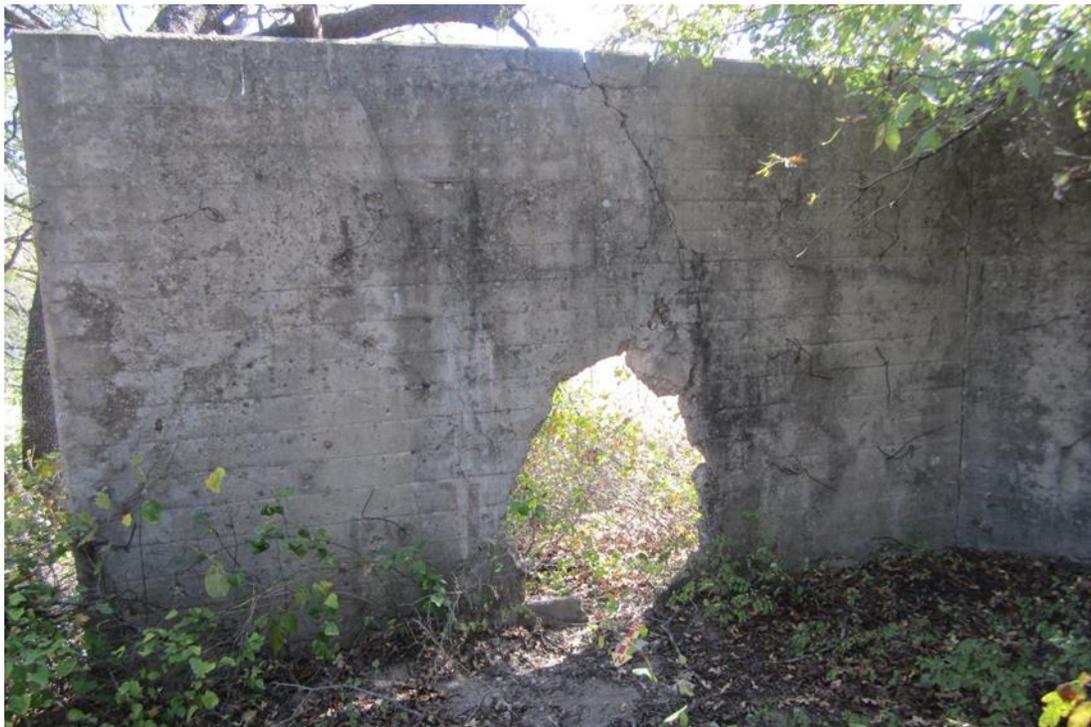
Northeast wall width	.92 m (3 ft)
Northeast wall height	2.14 m (7 ft)
Southeast wall width	4.94 m (16 ft 2 in)
Southeast wall height	2.99 m (9 ft 9 in)
Southwest wall width	4.91 m (7 ft 10 in)
Southwest wall height	2.15 m (7 ft)

Figure 17 - Munitions Damage on Feature 5

Figure 19 - Munitions Damage Interior

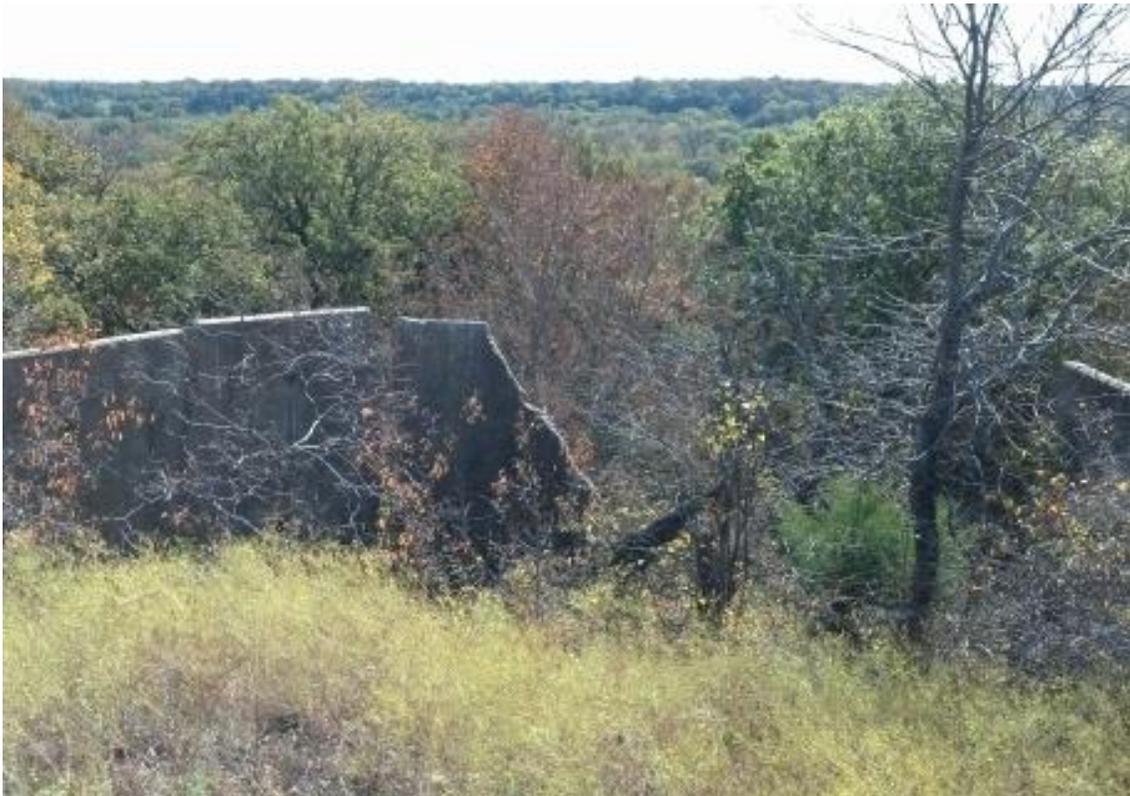
Figure 20 - Feature 7

Feature 7 is a bunker similar to Features 5 and 6, but sits on a neighboring property where we did not have permission to survey. The structure is designated a feature because it is part of the same original complex, and is easily visible from the landowner's property.

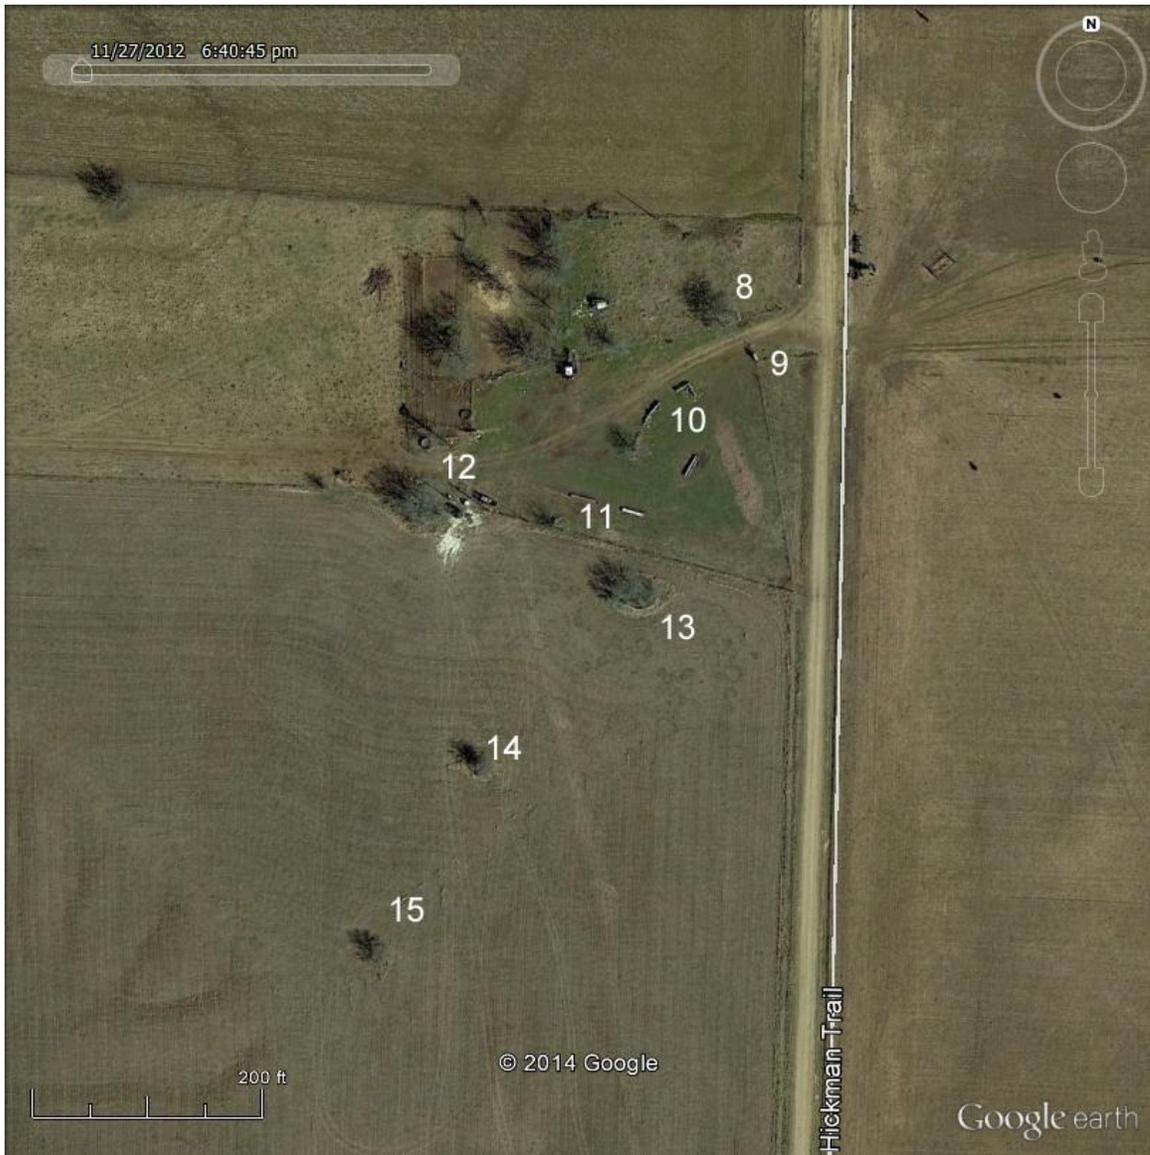
Figure 21 - Mock Village Feature Locations

The site of the Combat Village is now located along Country Road 410 (Figure 21). Today, most of the area consists of cattle pastures and farm land, but a series of small walls that were once training ground buildings remain, as well as the bases of an archway that were constructed at the entrance of the village. These structures are retained in a fenced area used for corralling cattle and for parking (Figures 22 - 23). Within the area of the small walls there is a circular construction that was dubbed the “wishing well” by the locals, and may have been constructed to represent a village’s central well.

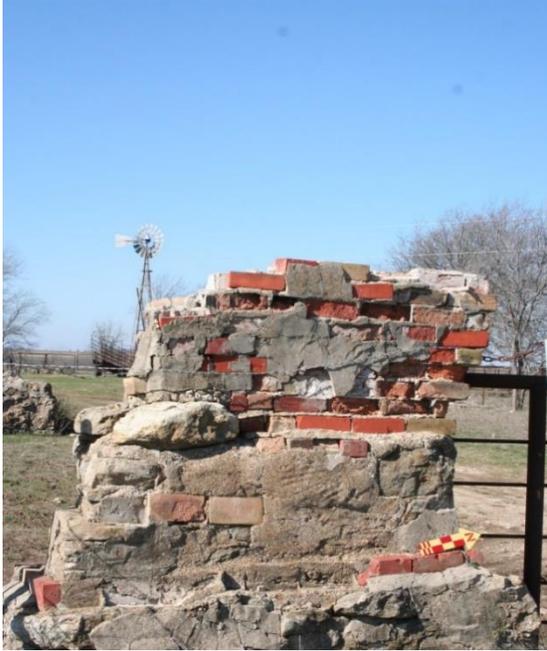
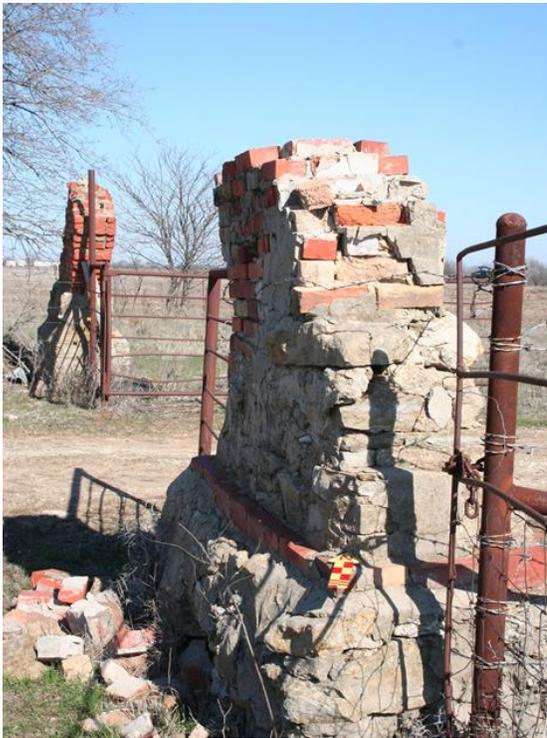
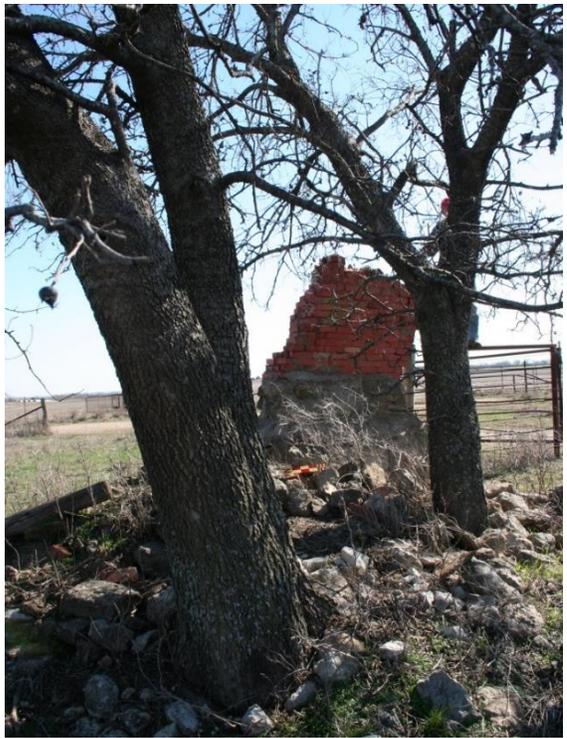
The front archway is a brick, mortar, and cement construction that served to mark the entryway to the mock village, though it may have been constructed as two separate pieces designed to look like the remnants of an entrance. The north section is designated Feature 8, and the south part Feature 9 (Figures 24 – 27). Both segments are of concrete construction with a brick and mortar core, with the brick section exposed above the base. Feature 8 has the number 1492 placed in the cement base. Bricks lie scattered around both segments, the result of fall from the crumbling features over the years.

North Arch		South Arch	
N-S	2.1 m (6 ft 10 in)	N-S	2 m (6 ft 7 in)
E-W	.85 m (2 ft 9 in)	E-W	.97 m (3 ft 2 in)
Height	2.44 m (8 ft)	Height	1.87 m (6 ft 2 in)

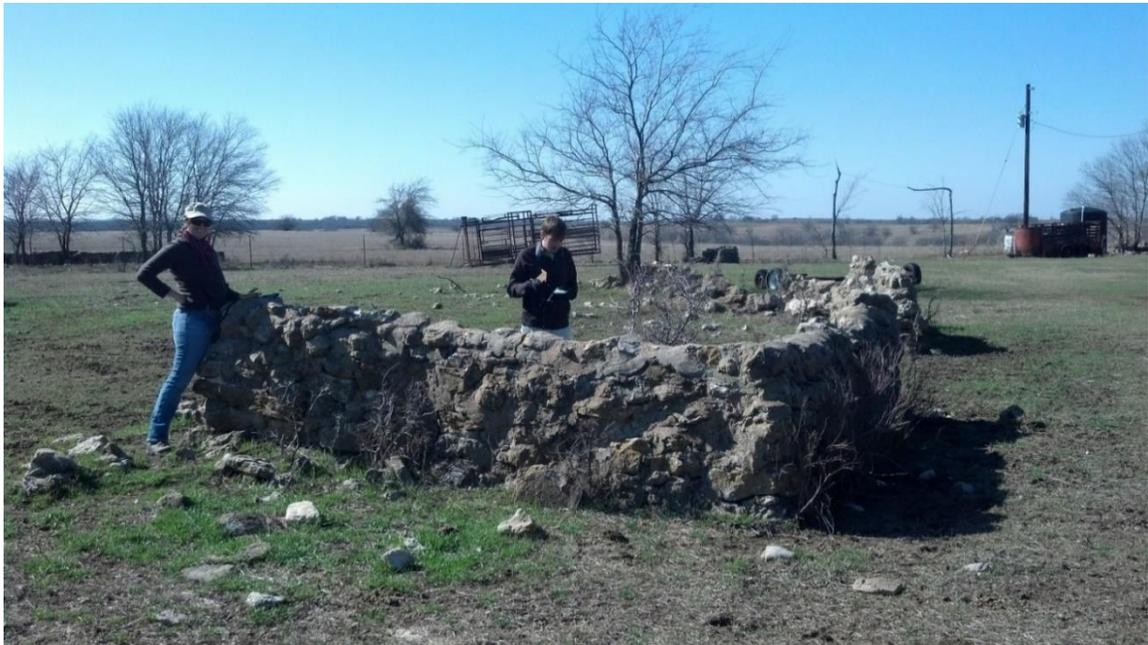
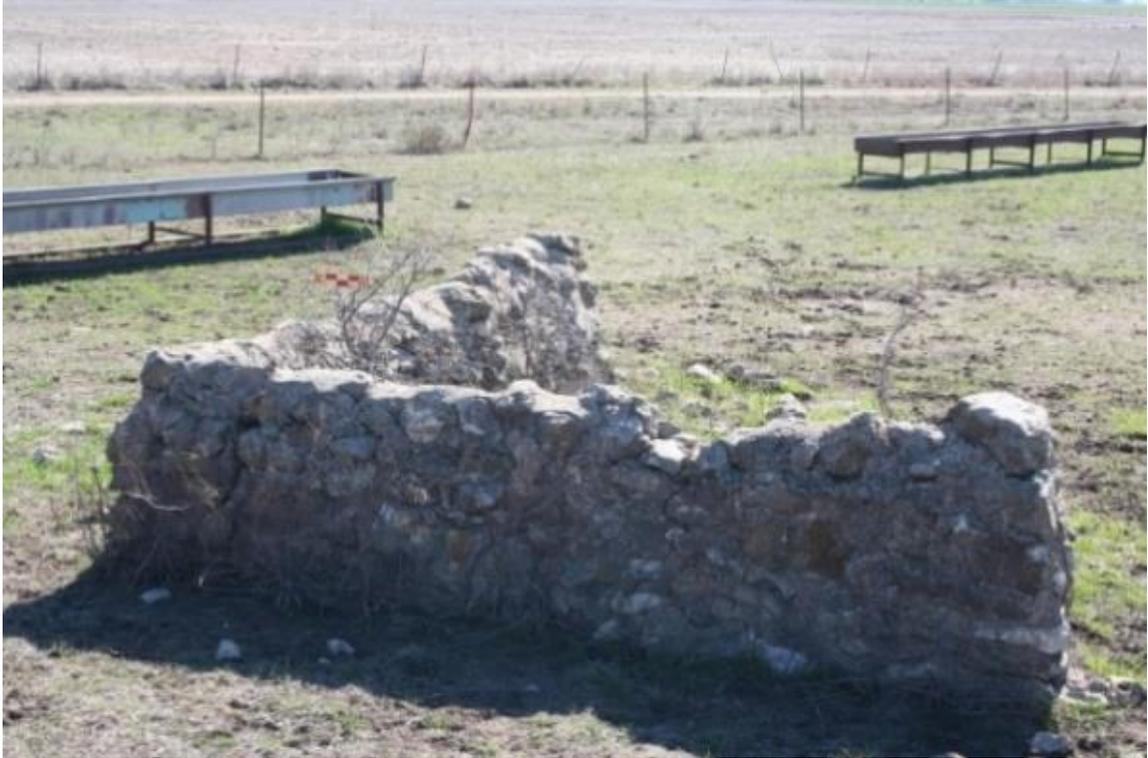
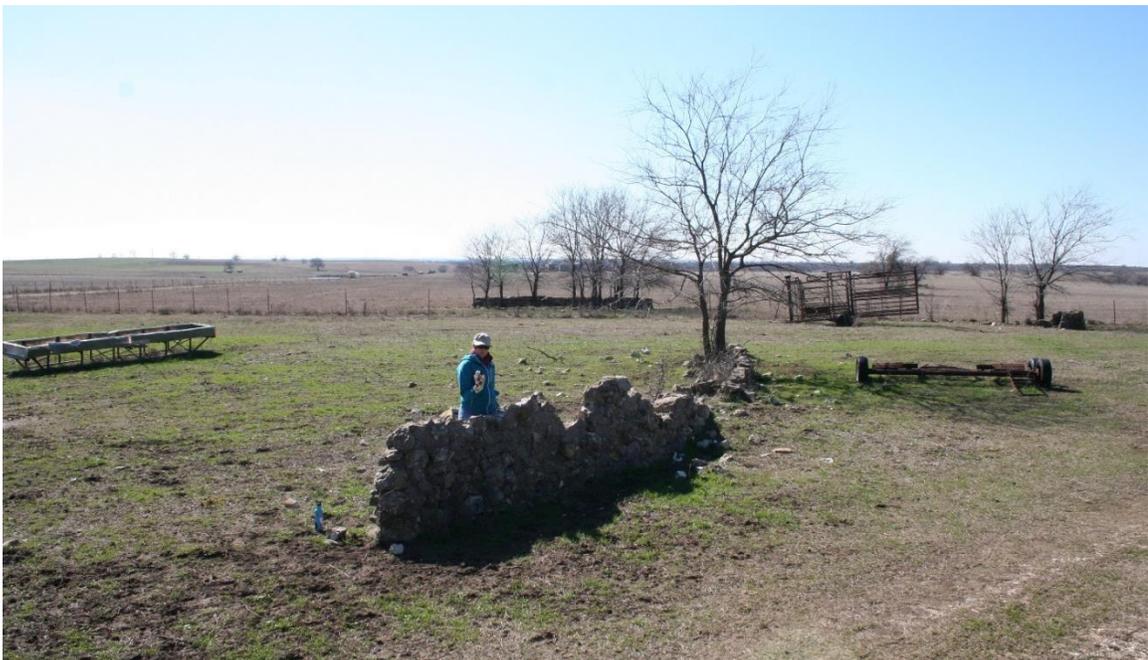
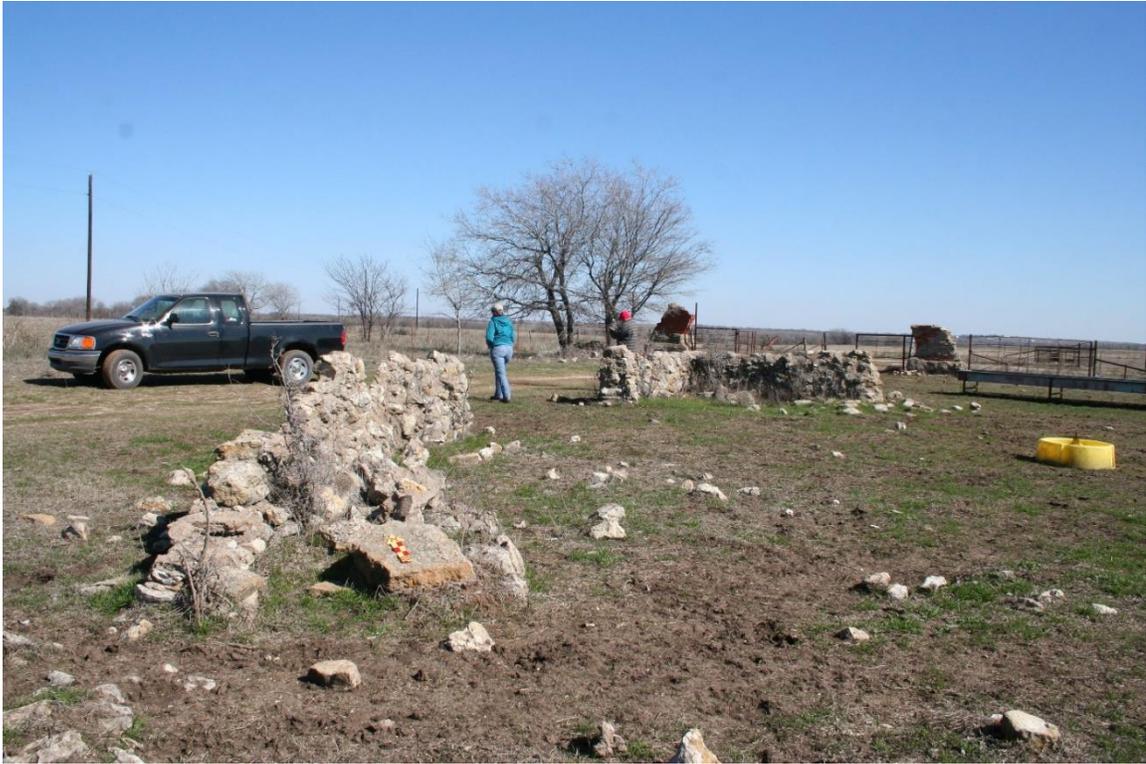
The central walls of the Mock village are of stone and mortar construction. The remaining walls within the corral were left standing by the land owner. While there is a certain amount of wall fall located around these features, there does not appear to be any floor foundation within the walled area. The construction neither conjoins any foundation, nor is there any change in the soil or grass to suggest a buried foundational structure. The visible construction of Feature 10 strongly suggests that the Combat Village was constructed to appear ruined in order to simulate bombed out regions. Feature 10 is formed by three wall segments that form a curved structure. The eastern segment has a short straight side stretching south to north towards a 90° corner that extends west. The central fragment continues curving gradually along a shape that is continued with the eastern fragment (Figures 28 – 31).

East Fragment	
East - West length	4.07 m (14 ft 4 in)
North - South length	3.88 m (12 ft 9 in)
Average Width	.55 m (1 ft 10 in)
East end height	.98 m (3 ft 2 in)
Corner height	.97 m (3 ft 2 in)
South end height	.94 m (3 ft 1 in)
Central Fragment	
Width at north end	.1 m (4 in)
Height at north end	1.01 m (4 ft 4 in)
Distance to center	3.16 m (10 ft 4 in)
Height at center	1.07 m (3 ft 6 in)
Center to south end	4.49 m (14 ft 9 in)
Height at south end	.16 m (6 in)
Width at south end	.4 m (1 ft 4 in)
Western Fragment	
Width at north end	.36 m (1 ft 2 in)
Height at north end	.27 m (10 in)
Length north to south	5.69 m (18 ft 8 in)
Width at south end	.45 m (1 ft 6 in)
Height at south end	.49 m (1 ft 7 in)

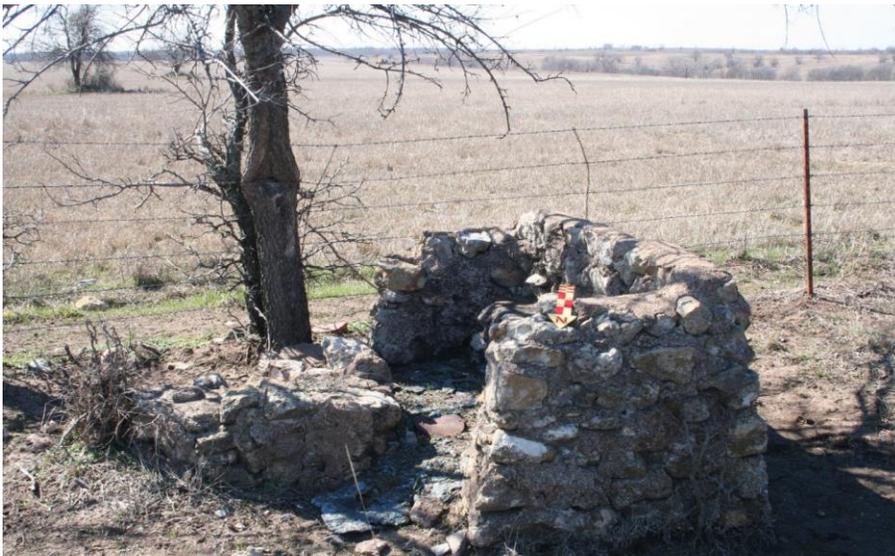
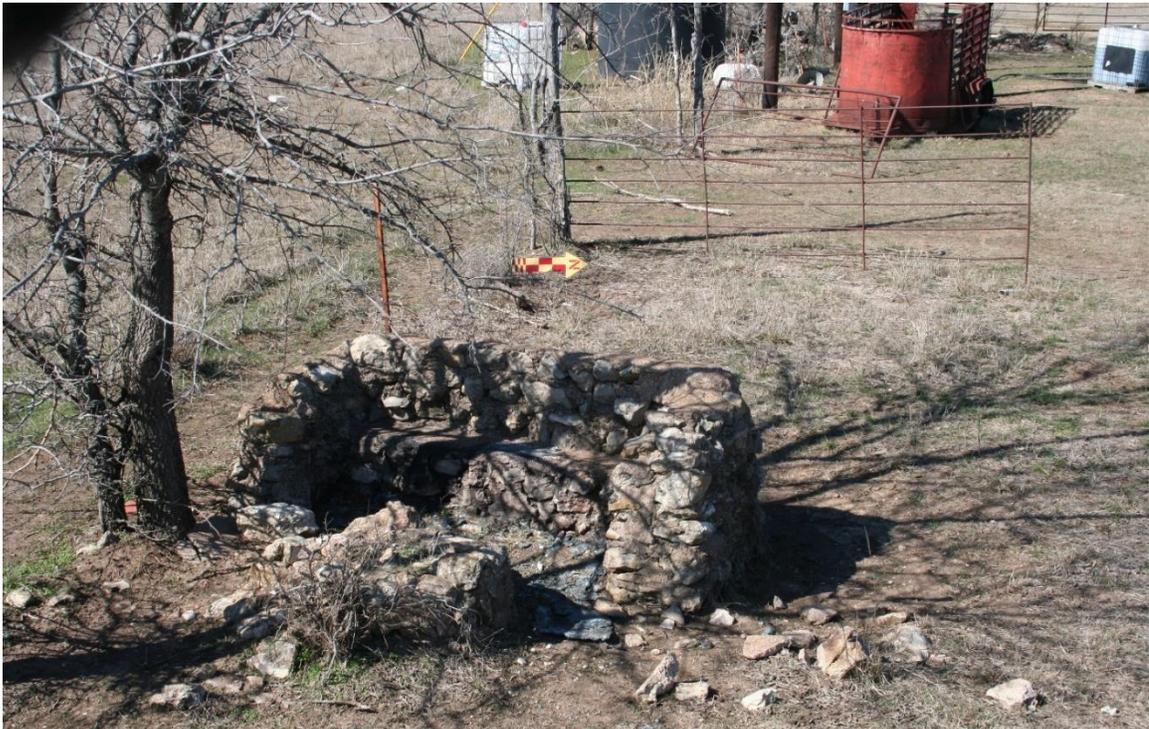
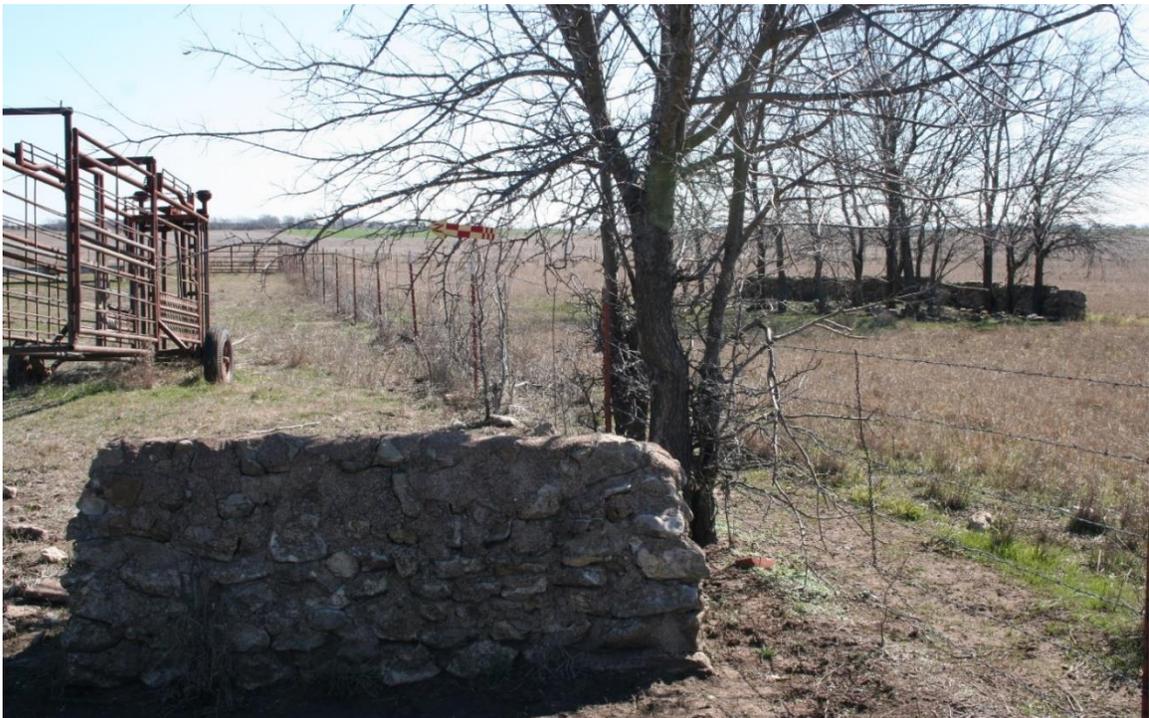
North side length	.98 m (3 ft 3 in)
NW Corner height	.91 m (3 ft)
SW corner height	.77 m (2 ft 6 in)
S side length	.99 cm (3 ft 3 in)
