The Western Front in the Backyard
The Archaeological Survey of Camp Howze, Texas

A Thesis

Anthropology

August, 2014

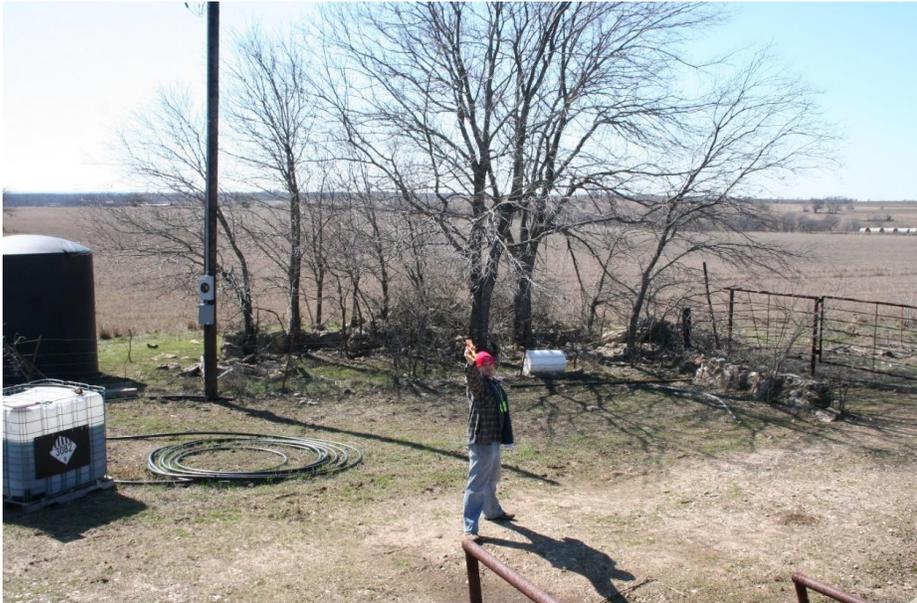
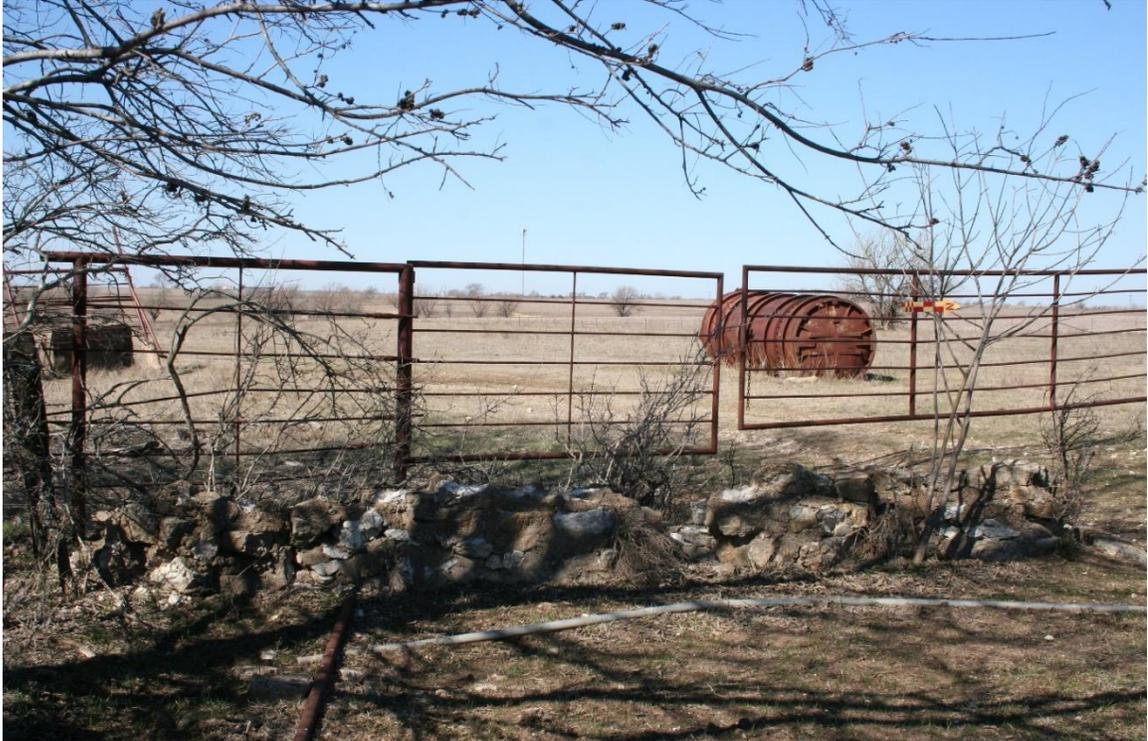
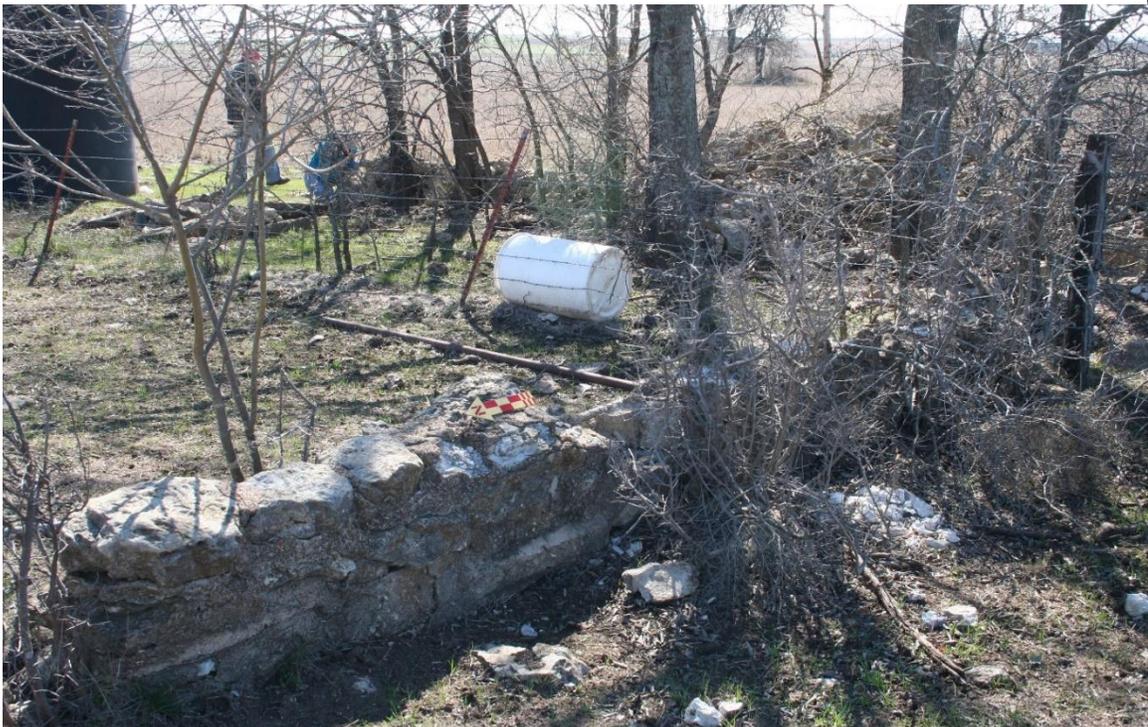
In the southwest corner of the corral, Feature 12 was identified. The feature is a simple wall structure that has suffered some damage due to the growth of a nearby tree. The feature consists of two parts: a short northern wall that is largely clear of overgrowth, and the more fully overgrown southern wall (Figures 36 – 38). Table 8 provides measurements of Feature 12.

North Wall		South Wall	
South end width	.4 m (1 ft 4 in)	East end height	.46 m (1 ft 6 in)
South end height	.08 m (3 in)	East end width	.35 m (1 ft 2 in)
N-S length	5.07 m (16 ft 7 in)	E-W to center point	3.53 m (11 ft 7 in)
North end width	.4 m (1 ft 4 in)	S-N sub wall length	.93 m (3 ft)
Height	.5 m (1 ft 8 in)	Center to west side	5.2 m (1 ft 5 in)
		West width	.3 m (1 ft)
		Height	.41 m (1 ft 4 in)

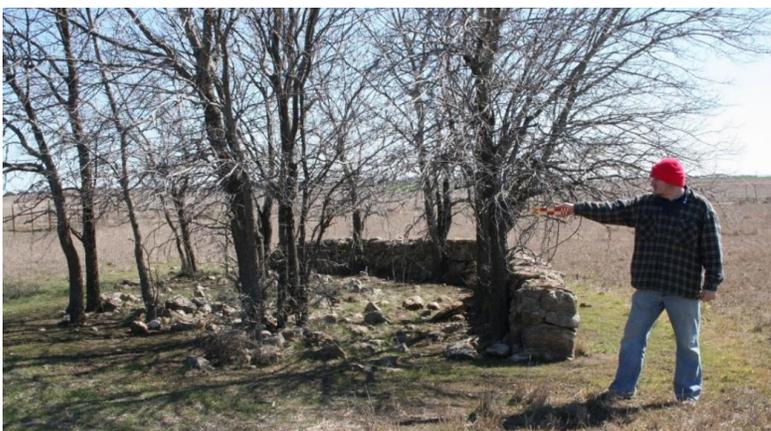
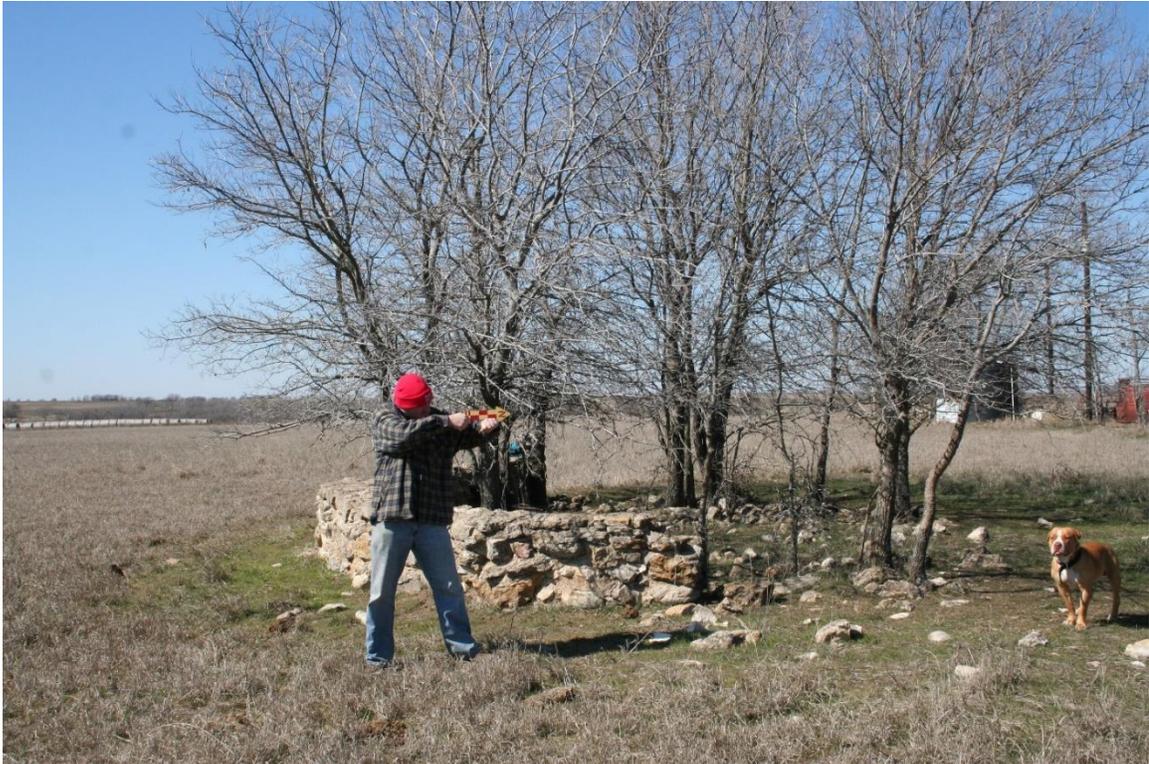
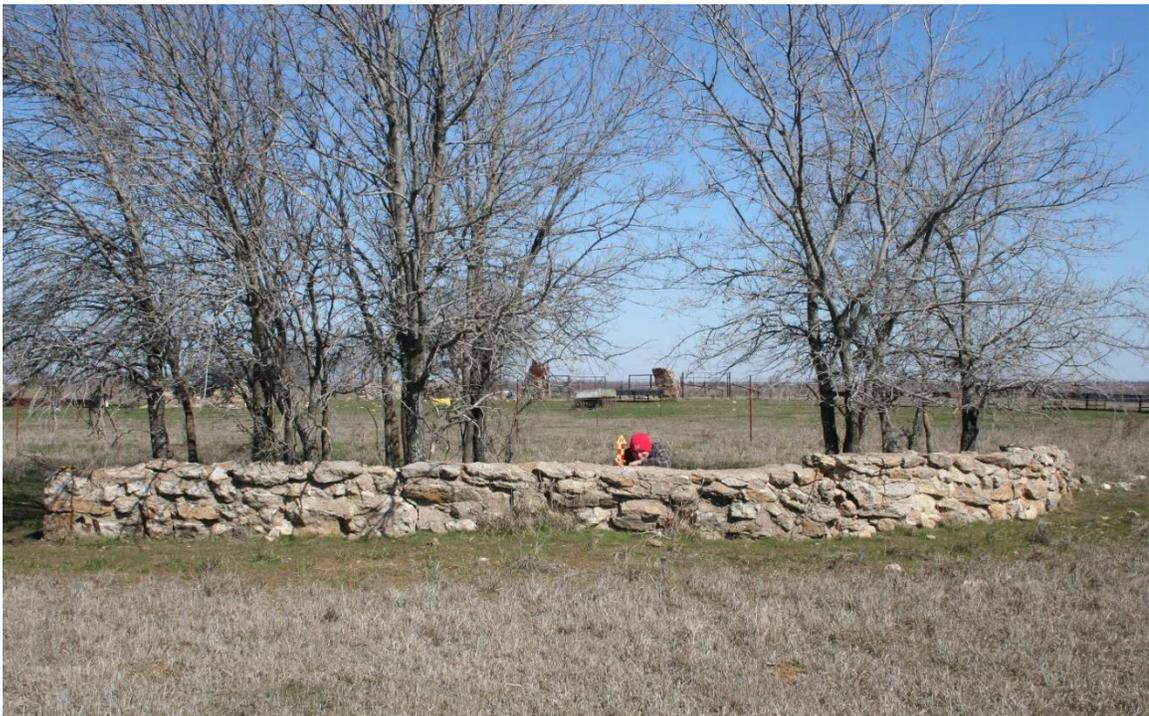
Feature 13 is a long section of a stone wall located just to the south of the corral (see Table 9 for measurements). The wall is of stone construction and curves along its length towards the north. The top of the wall is leveled off, but the interior area contains large quantity of collapsed wall fall, with a number of trees growing around the stone. Five of these trees are growing directly against the north side of the wall (Figures 39 – 41).

West Width	.59 m (1 ft 11 in)
West Height	.63 m (2 ft 3 in)
Length W-E	6.08 m (22 ft 11 in)
Height at center	.8 m (2 ft 7 in)
Width	.46 m (1 ft 6 in)
Center to "tree" length	.33 m (1 ft 1 in)
Height	.7 m (2 ft 6 in)
Width	.56 m (1 ft 10 in)
Tree to North end	2.49 m (20 ft 9 in)
Height	.45 m (1 ft 6 in)
Width	.53 cm (1 ft 9 in)

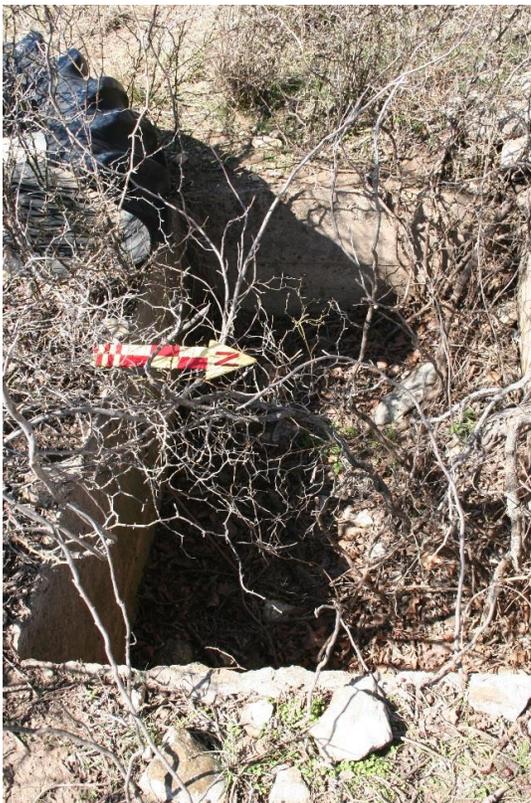
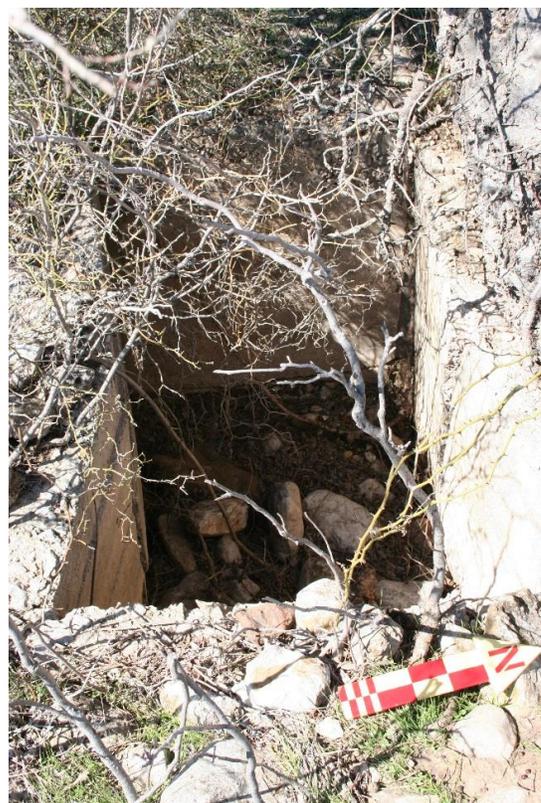
These two identically sized features are concrete walled shafts that have been filled in since the closing of the base, the original purpose of which is unknown. There is wall fall around both shafts, as well as brush growth. Feature 14 is located south of the corral, with Feature 15 directly south of there. The two Features share identical measurements (Figures 42 – 43 and Table 10).

North to South	.94 m (3 ft 1 in)
East to West	1.57 m (5 ft 1 in)

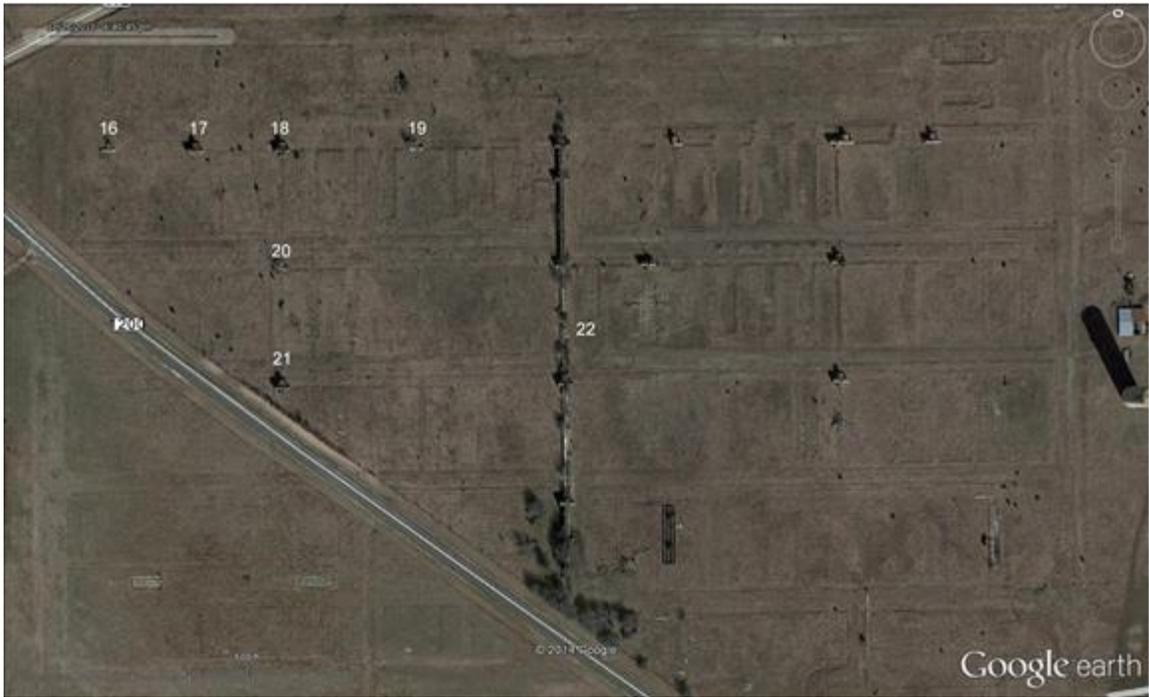
Figure 44 - Hospital Complex Feature Locations

The largest survey area covered half of the main base complex and is now located between Farm to Market Roads 1200 and 1201, and south of County Road 412 (Figure 44). This area contained the base hospital and the hospital constructed for treatment of POWs.

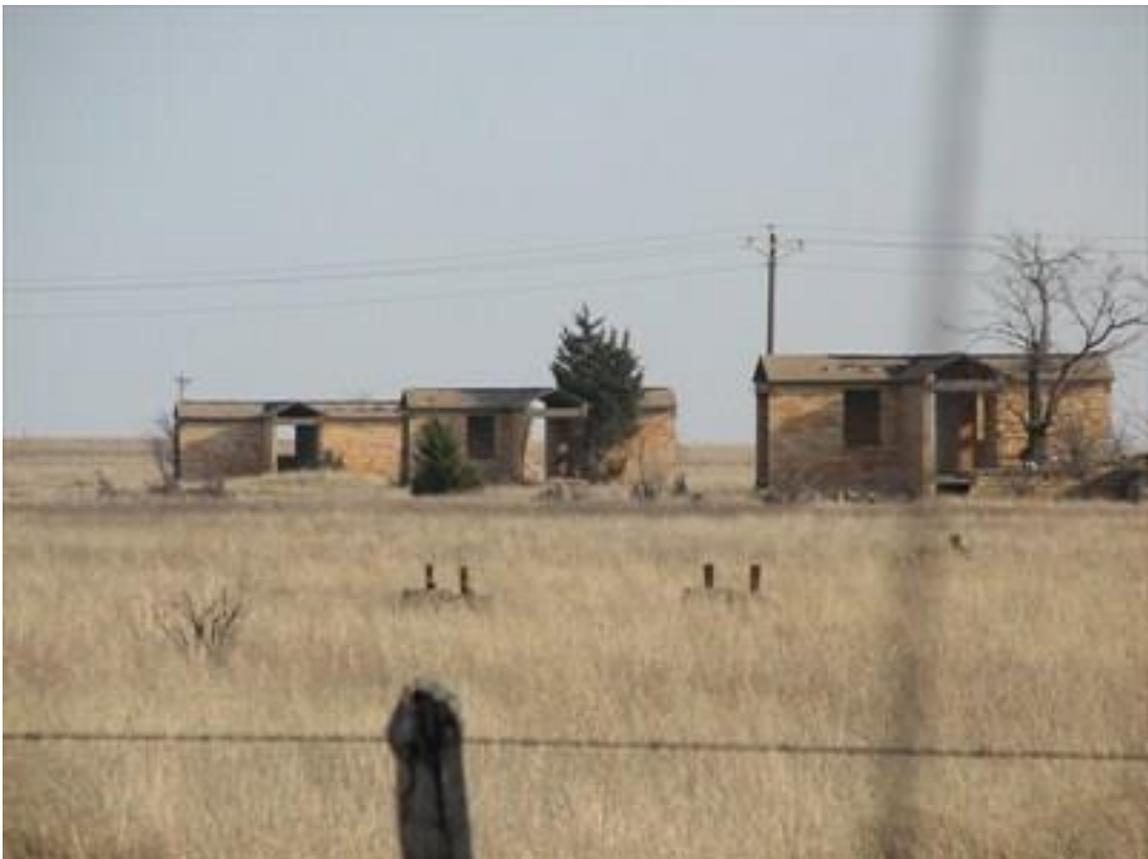
Figure 45 - Hospital Complex features

The majority of the former medical complex is now cattle pasture, and part of which includes the majority of the 86th Infantry barracks and office area (Figure 45). All of the wooden components of the hospital were sold off in the post-war auctions, and the remaining brick and concrete structures have collapsed. The majority of concrete pier formations remain in place, though some have been pulled from the ground, and one near Feature 16 was used to plug the open sewer pipes located in the northwest corner of that feature. There are no missing gaps in the concrete pier formations to show that any complete formations were removed, suggesting difficulty in removing the piers. The formations now dot wide sections of the pastures that used to house the main complex, an indication of where Camp Howze's wooden buildings stood.

The remaining concrete and brick structures have since fallen into ruin. Most are still standing, though all of the documented features show evidence of collapse. The Long Hall has collapsed wall in multiple areas, and a large section in the middle that has completely caved. The eastern half of the base also shows concrete foundations for many

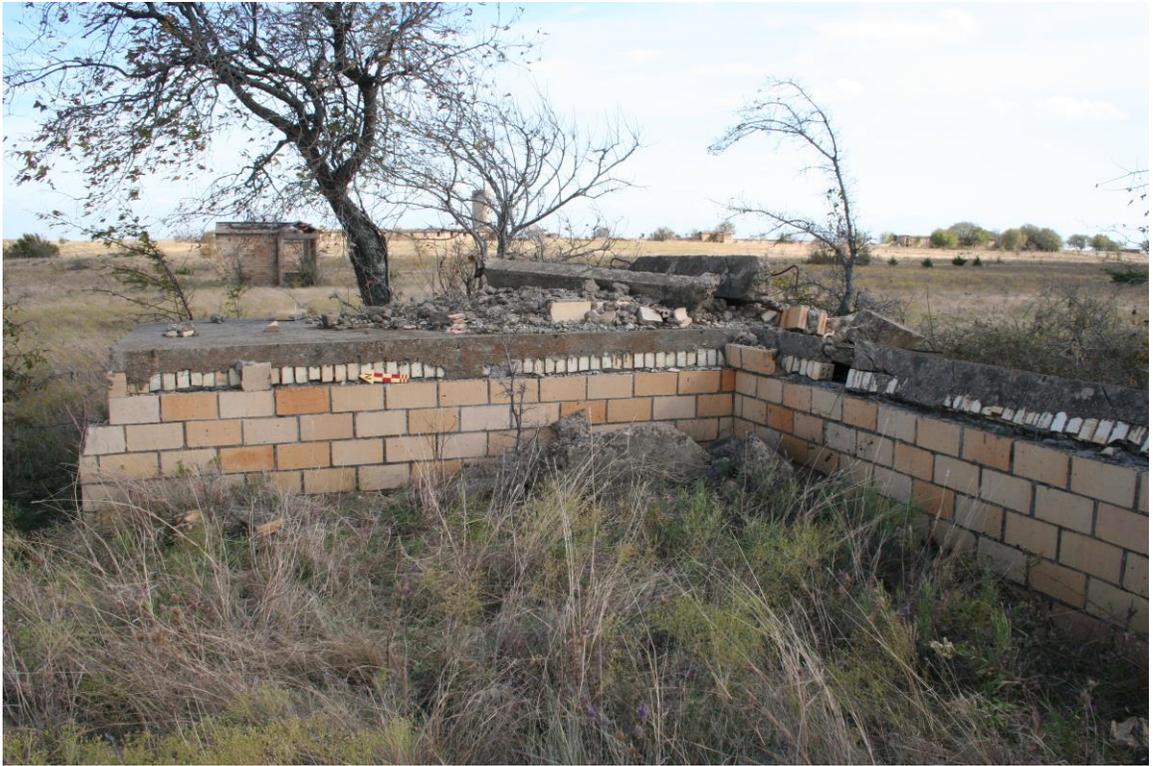
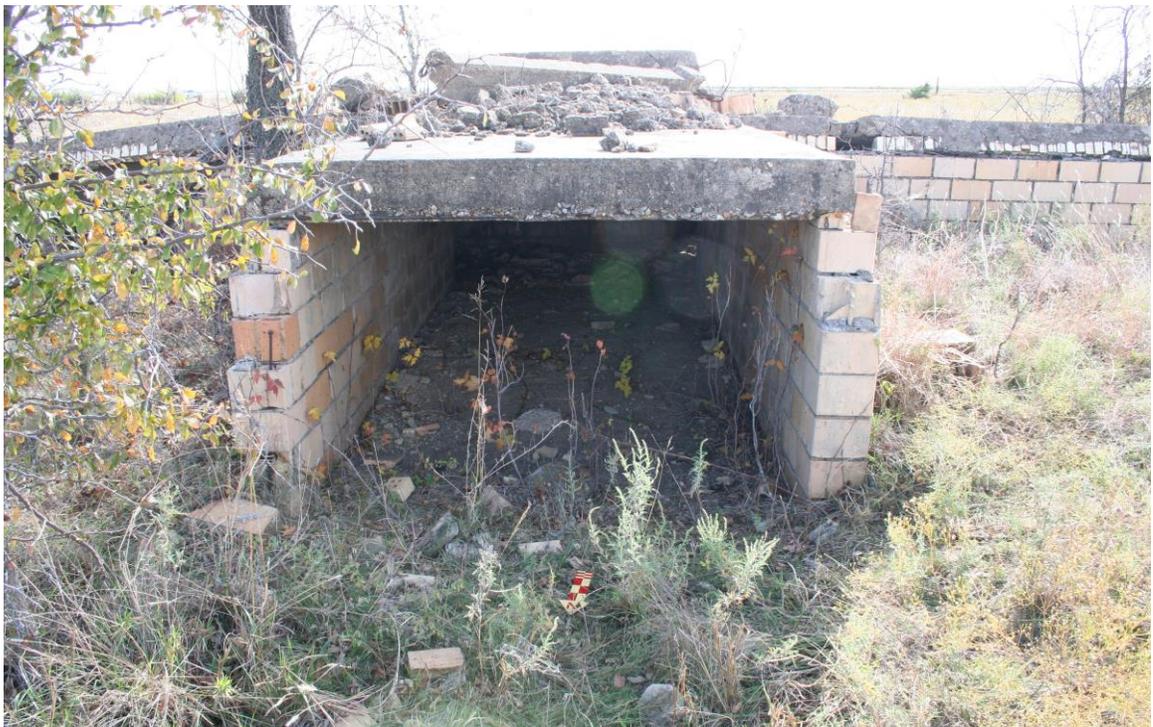
Feature 16 is a 4 way brick and concrete hallway intersection with East, North, and West projections. The structure is largely collapsed, with the north floor still intact. No walls or roof remain standing (Figures 46 – 47). Table 11 lists the measurements for the feature.

North to South length 6.08 m (20 ft)		East to West length 9.67 m (31 ft 9 in)	
North Projection		East Projection	
Length	3.85 m (12 ft 7 in)	Length	3.56 m (11 ft 7 in)
Width	2.24 m (7 ft 4 in)	Width	2.6 m (8 ft 6 in)
Elevation	1.31 m (4 ft 3 in)	Elevation	.72 m (2 ft 3 in)
South Projection		West Projection	
Length	Collapse	Length	3.87 m (12 ft 8 in)
Width	Collapse	Width	2.6 m (8 ft 6 in)
Elevation	Collapse	Elevation	.65 m (2 ft 2 in)

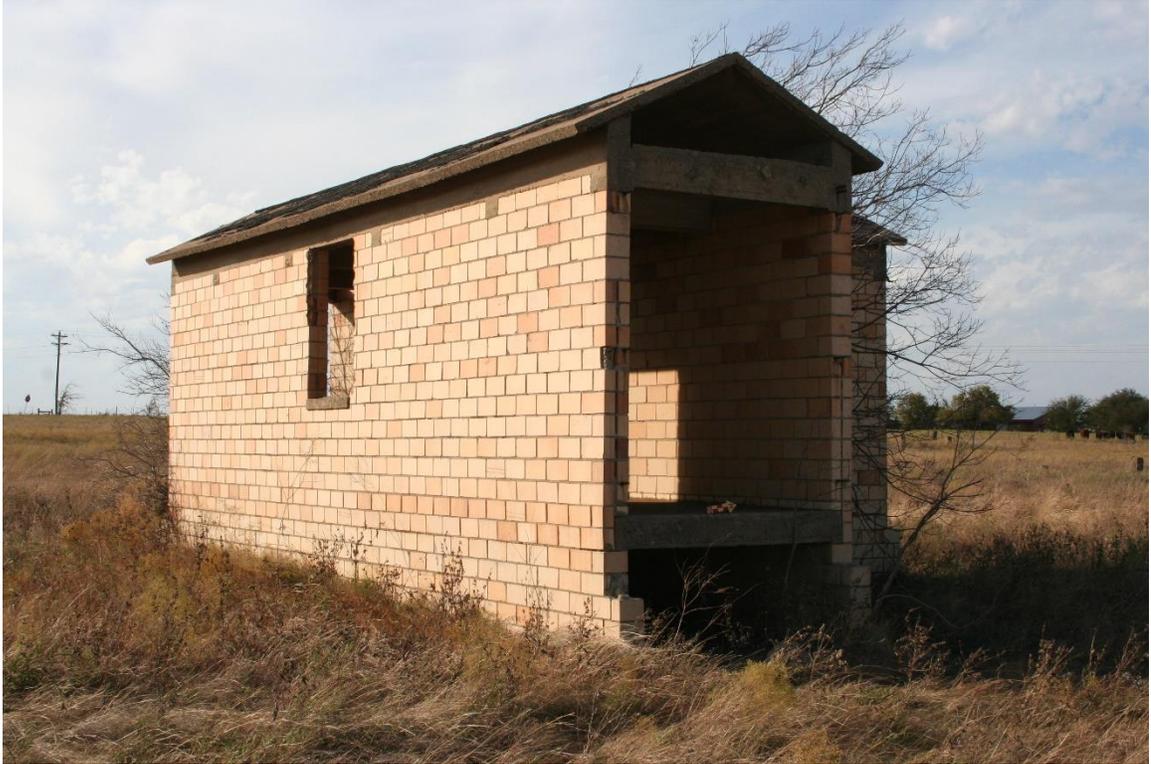
Figure 48 - Feature 17

Feature 17 is a mostly intact brick and concrete hallway T-intersection with no south projection (Figure 48). Hanging metal pipe holders were found still attached to concrete beams, identical to those described as 6-inch government pipe holders in the metal artifact analysis section (Figure 61). Measurements for Feature 17 are listed in Table 12.

North Projection		East Projection	
Length	3.89 m (12 ft 9 in)	Length	3.83 m (12 ft 6 in)
Width	2.24 m (7 ft 4 in)	Width	2.24 m (7 ft 4 in)
Elevation	1.08 m (3 ft 6 in)	Elevation	1.05 m (3 ft 5 in)
South Projection		West Projection	
Length	Not present	Length	3.83 m (12 ft 6 in)
Width	Not present	Width	2.24 m (7 ft 4 in)
Elevation	Not present	Elevation	1 m (3 ft 3 in)

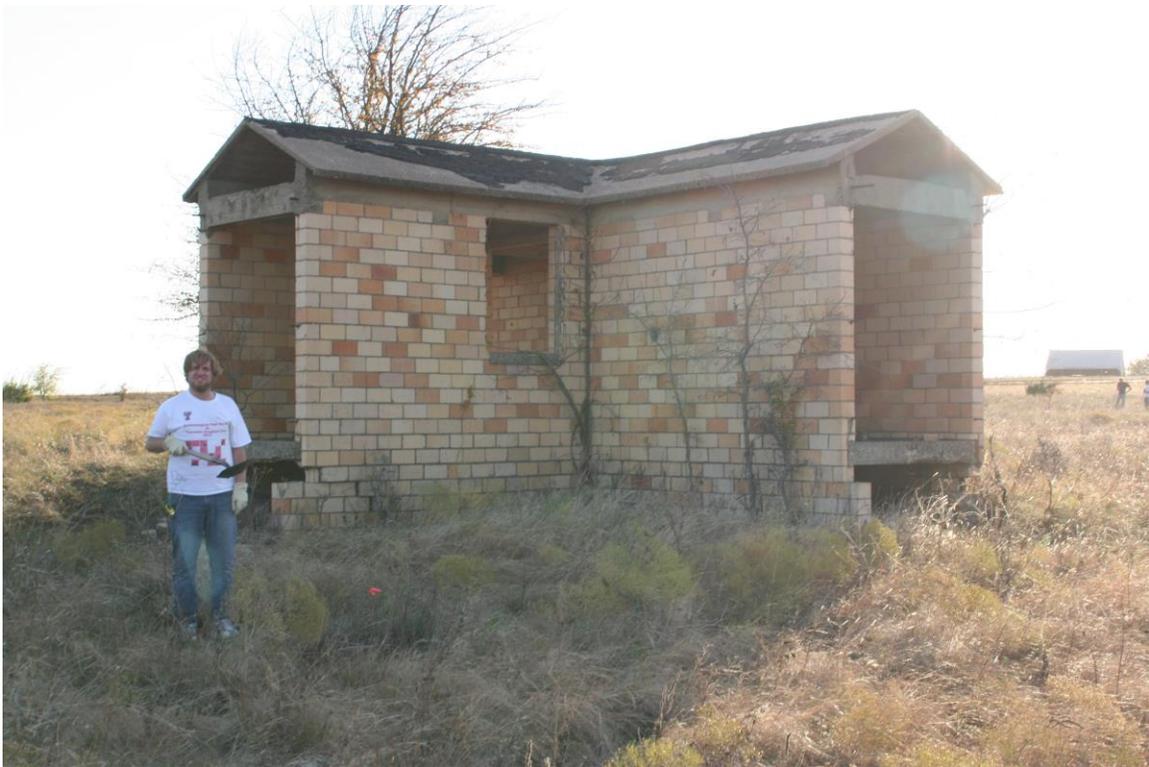
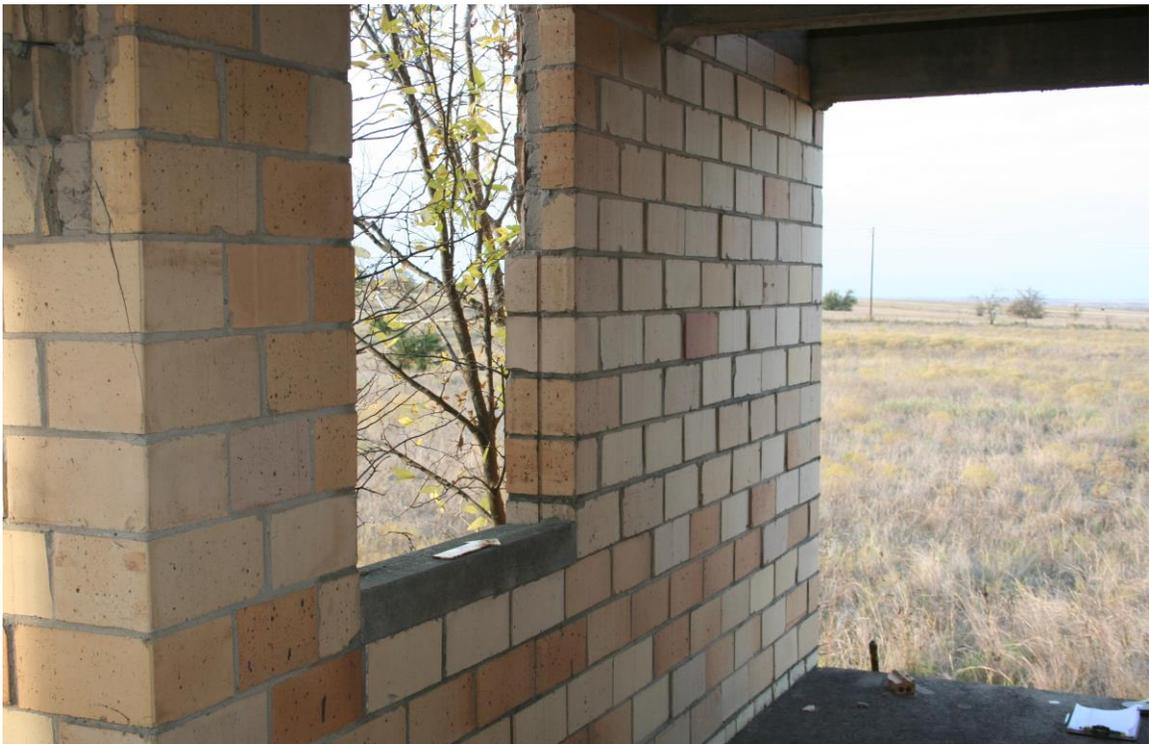
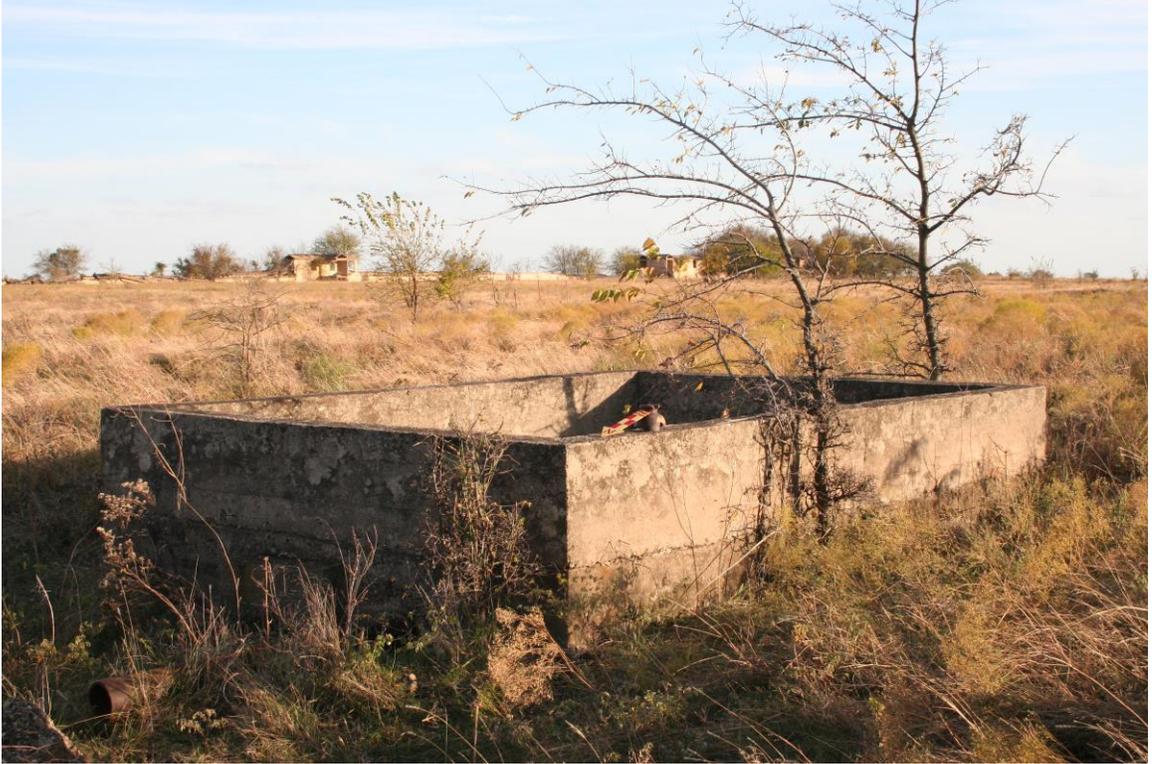
Feature 18 is a four-way brick and concrete hallway intersection (Figures 49 – 51). Windows are arranged in a standardized pattern so that a window is located on the left side of each projection when facing out. Each window is 60 cm (2ft) from the left side of each projection when facing out. Each window is 60 cm (2ft) from the intersection corner, and 99 cm (3ft 3 in) wide. The eastern corner of the southern projection has collapsed. Floor elevations were not recorded for this feature. A concrete cistern is located directly to the south east of the structure, measuring 4.06 m (13ft 4 in) north to south, 2.84 m (9ft 3 in) east to west, and 2.6 m (8ft 6 in) deep. Table 13 lists measurements of the feature.

North to South length 9.57 (31 ft 5 in)		East to West length 9.57 (31 ft 5 in)	
North Projection		East Projection	
Length	3.86 m (12 ft 7 in)	Length	3.86 m (12 ft 7 in)
Width	1.85 m (6 ft)	Width	1.85 m (6 ft)
Elevation	not recorded	Elevation	not recorded
South Projection		West Projection	
Length	3.86 m (12 ft 7 in)	Length	3.86 m (12 ft 7 in)
Width	1.85 m (6 ft)	Width	1.85 m (6 ft)
Elevation	not recorded	Elevation	not recorded

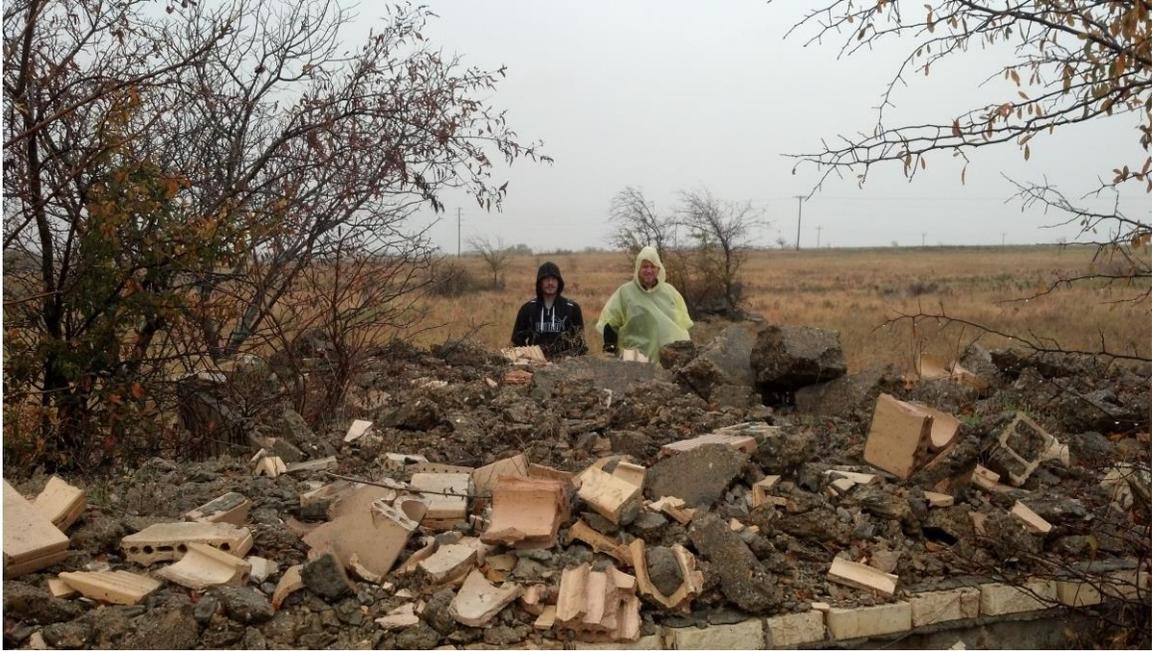
Figure 52 - Feature 19

Feature 19 is a brick and concrete T-Intersection with no southern projection. The roofs and walls have collapsed (Figure 52). Detailed measurements of the feature are provided in Table 14.

North Projection		East Projection	
Length	3.90 m (12 ft 9 in)	Length	3.87 m (12 ft 8 in)
Width	2.23 m (7 ft 4 in)	Width	2.23 m (7 ft 4 in)
Elevation	1.08 m (3 ft 6 in)	Elevation	.92 m (3 ft)
South Projection		West Projection	
Length	Not present	Length	3.87 m (12 ft 8 in)
Width	Not present	Width	2.23 m (7 ft 4 in)
Elevation	Not present	Elevation	1.18 m (3 ft 10 in)

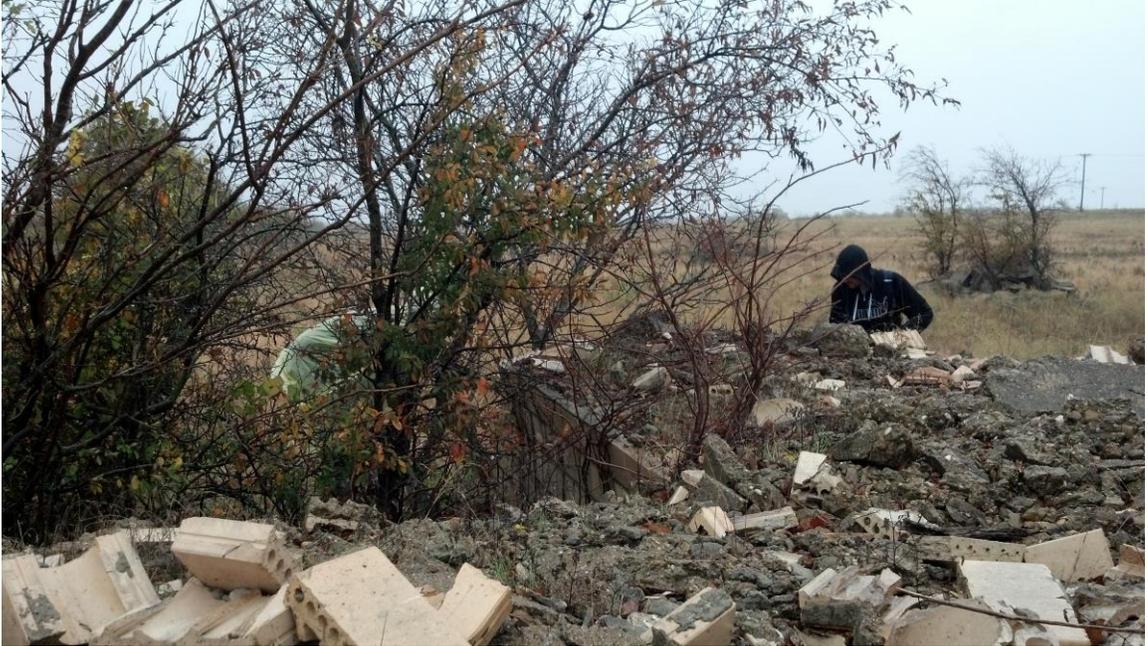
Figure 53 - Feature 20

Feature 20 is a four-way brick and concrete intersection that has collapsed (Figure 53). Measurements for the feature are provided in Table 15.

North to South length 9.57 (31 ft 5 in)		East to West length 9.57 (31 ft 5 in)	
North Projection		East Projection	
Length	3.86 m (12 ft 7 in)	Length	3.83 m (12 ft 6 in)
Width	2.12m (7 ft)	Width	2.08 m (6 ft 9 in)
Elevation	1.16 m (3 ft 9 in)	Elevation	.94 m (3 ft 1 in)
South Projection		West Projection	
Length	3.84 m (12 ft 6 in)	Length	3.82 m (12 ft 5 in)
Width	2.01 m (6 ft 7 in)	Width	2.15 m (7 ft 1 in)
Elevation	.96 m (3 ft 2 in)	Elevation	1.01 m (3 ft 4 in)

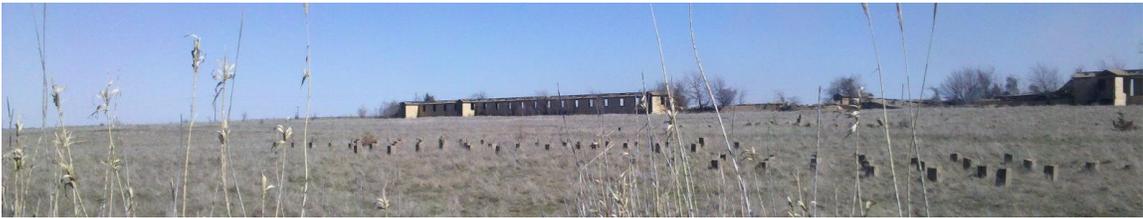
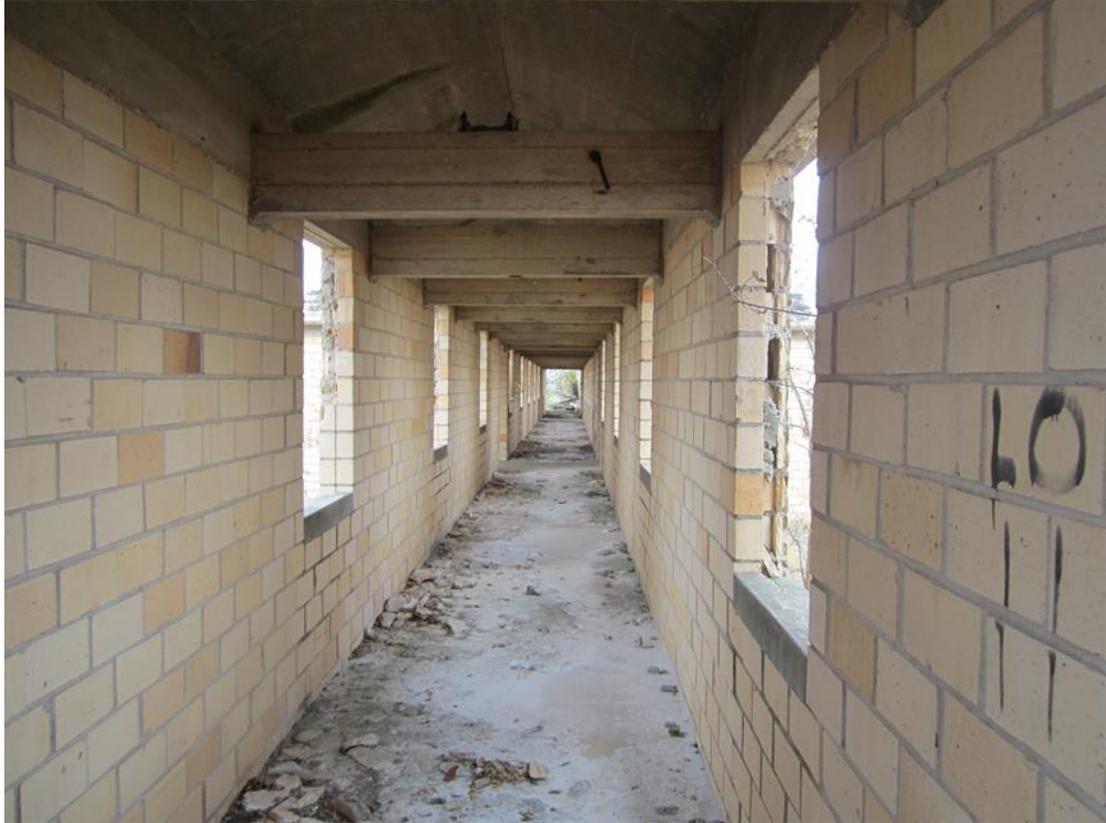
Cutting across the center of the hospital complex is the longest still extant structure of the area (Figures 54 – 57). The Long Hall matches the construction style of Features 16 – 21 but is one originally continuous hallway. The central and southern sections have collapsed over time. The long hall served as a central landmark during the survey. Graffiti within the interior and modern trash around the exterior attest to its continued visitation.

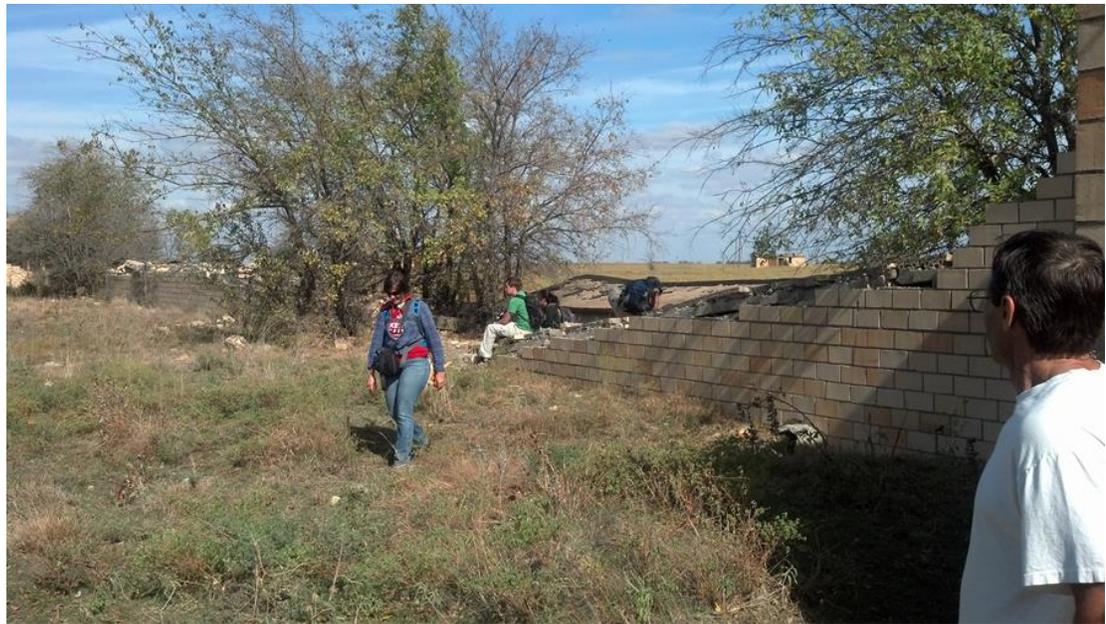
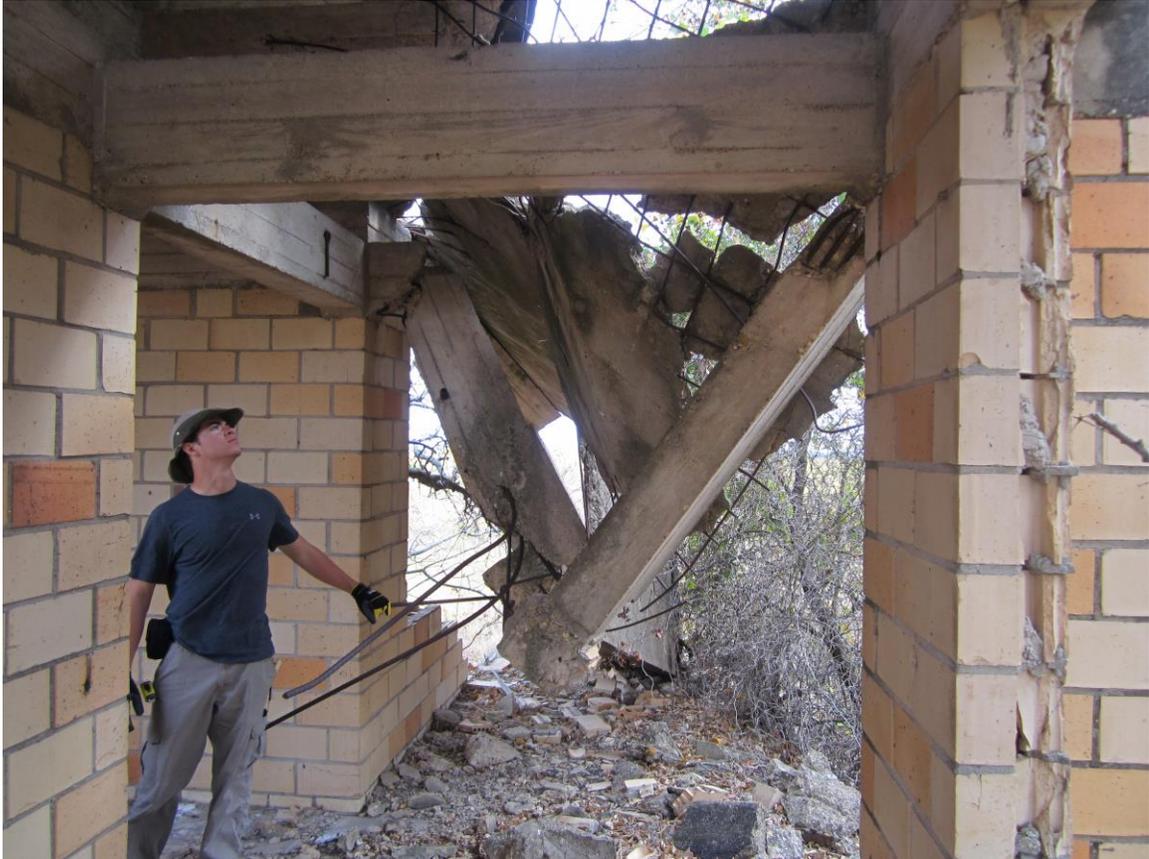
Figure 56 - The Collapsed Mid-Section of the Long Hall

Figure 57 - A Collapsed Section of the Long Hall

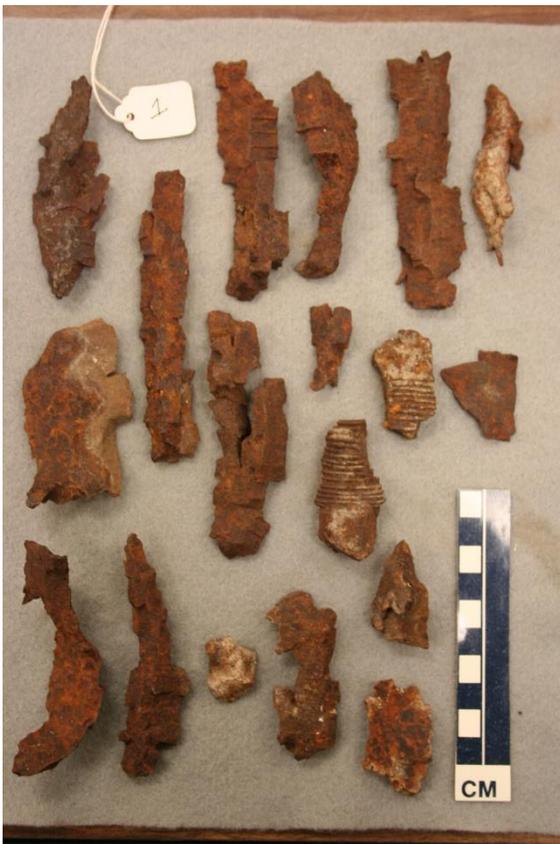
Figure 59 - Artillery Range Shrapnel

Between Features 2 and 3 lies the target field for the artillery. The field is a larger hilltop heavily pockmarked by repeated shelling, the damage made obvious by the relatively flat surface of nearby hilltops. A large amount of shrapnel debris still remains on the surface, and a sample was collected on the surface survey. However there remains a large amount of shrapnel scattered openly around the field.

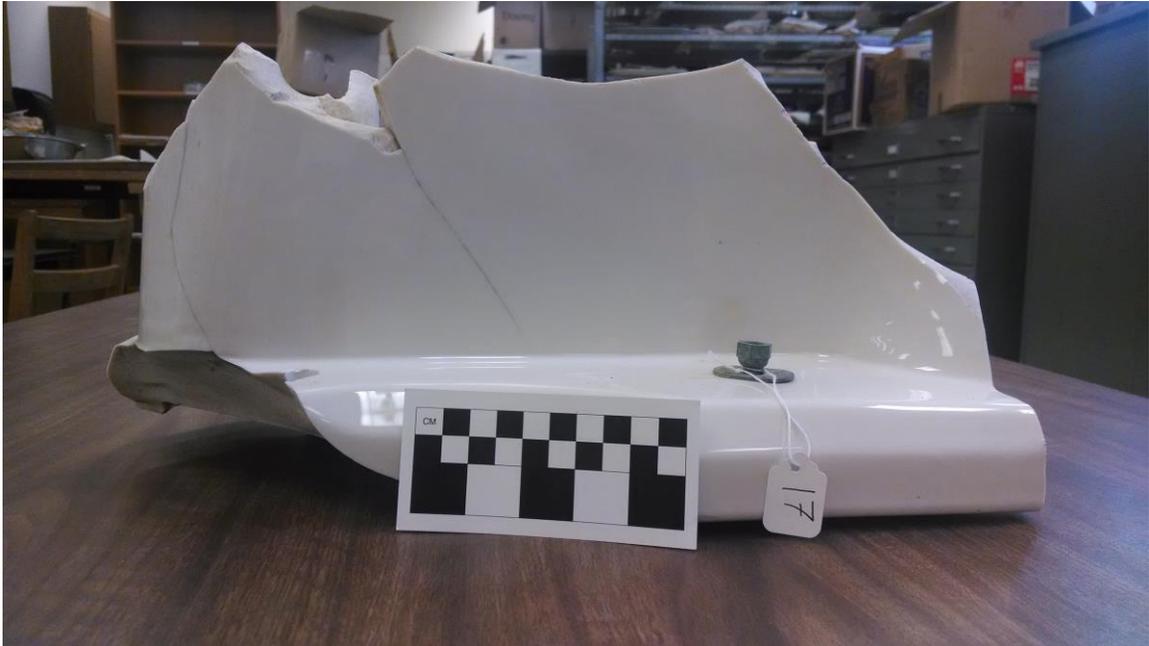
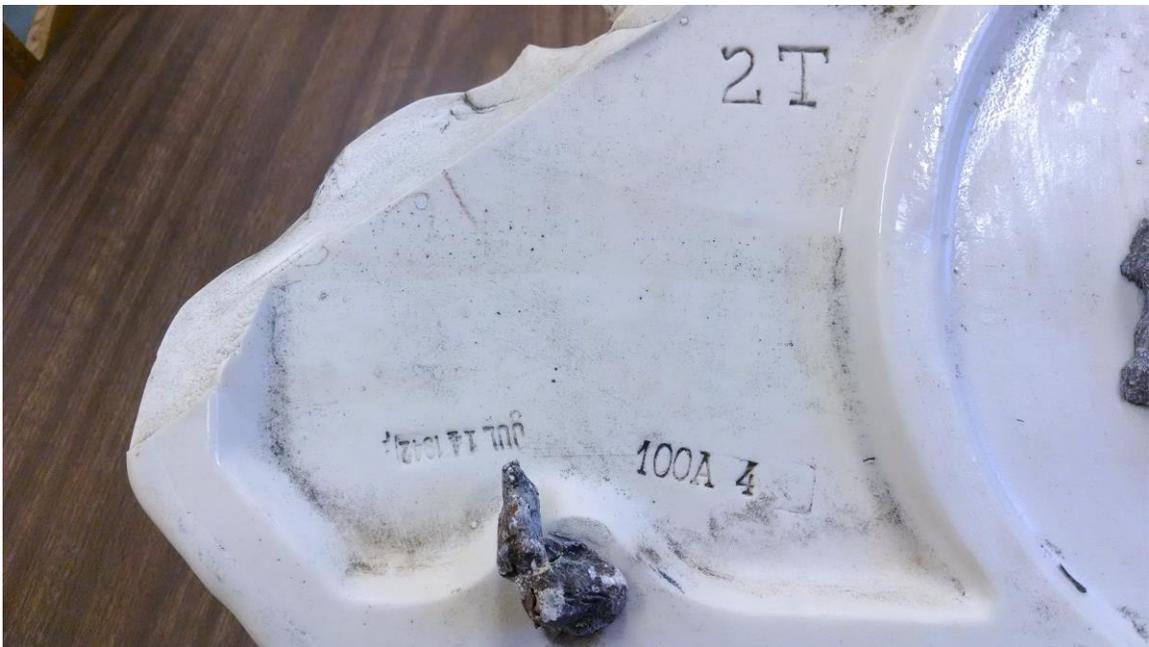
A number of broken toilets were found on the survey of the eastern portion of the medical complex. One large portion of a toilet bottom was collected and returned to the lab (Figure 95). The stool is mostly intact, with the tank broken off, and damage along the base. Marks along the bottom read - 2T, 100Z 4, Jul 14 1942, corresponding with the final construction of the base (Figure 96). The letters AJ are written on it, but are now mostly faded. Two metal bolts remain attached. Remnants of waterproofing putty remain

attached to the base. The toilet was taken as a sample from an area of the hospital that had similar pieces at the surface level, suggesting that this is a dump site.

Figure 95 - Toilet Profile View

Figure 96 - Toilet Maker's Marks

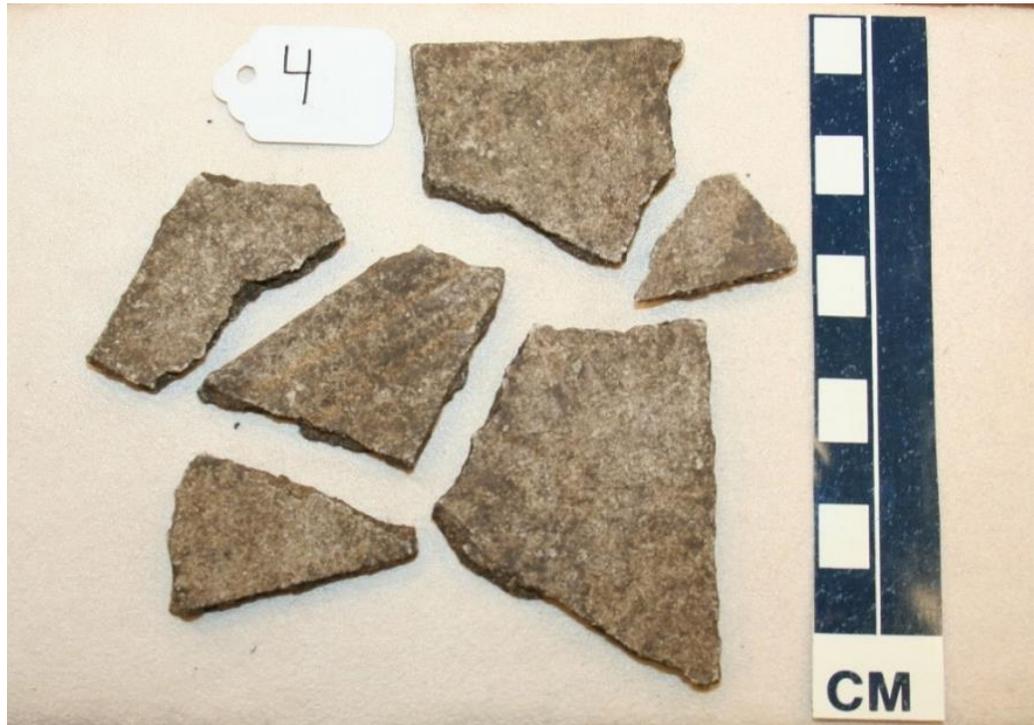
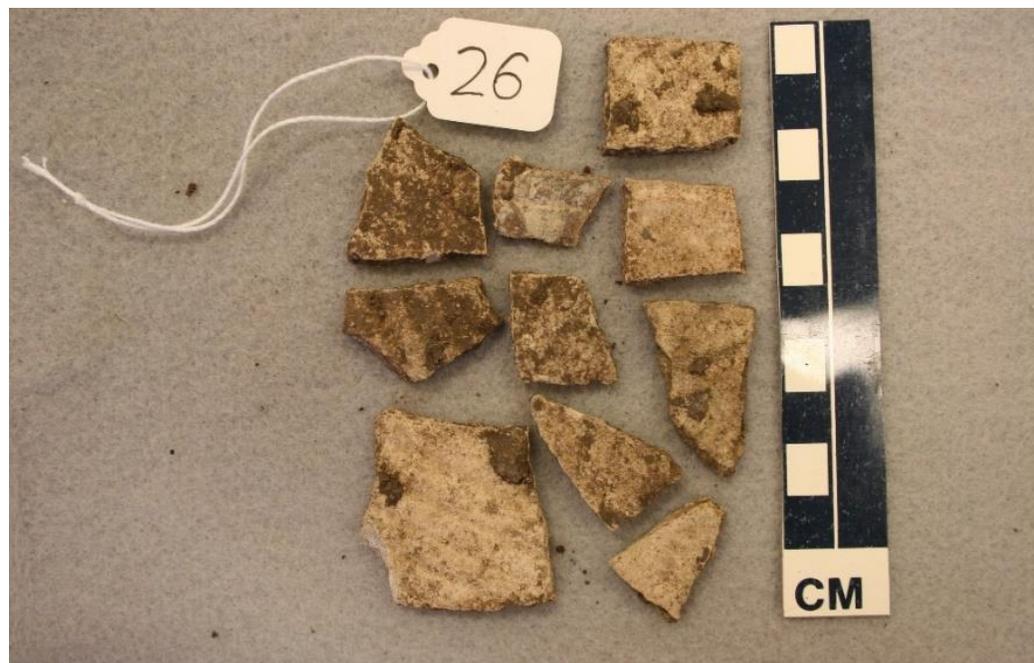
While one of the less commonly recovered artifacts, the asbestos siding recovered from several shovel tests may be the most significant artifacts for identifying the presence of a World War II era site. The temporary structures of Camp Howze were wooden frame construction, with asbestos siding (Figures 97 - 98). While the metal, glass, and ceramic artifacts are helpful and diagnostic, the presence of asbestos siding is a hallmark of that era of construction. Three shovel tests provided fragments of the asbestos siding, two within the western medical complex area, and one at the 86th infantry headquarters area. In total 22 pieces of siding were found.

Figure 97 - Asbestos from the Hospital Area

Figure 98 - Asbestos from the 86th Infantry Cantonment
