The Western Front in the Backyard
The Archaeological Survey of Camp Howze, Texas

A Thesis

Anthropology

August, 2014

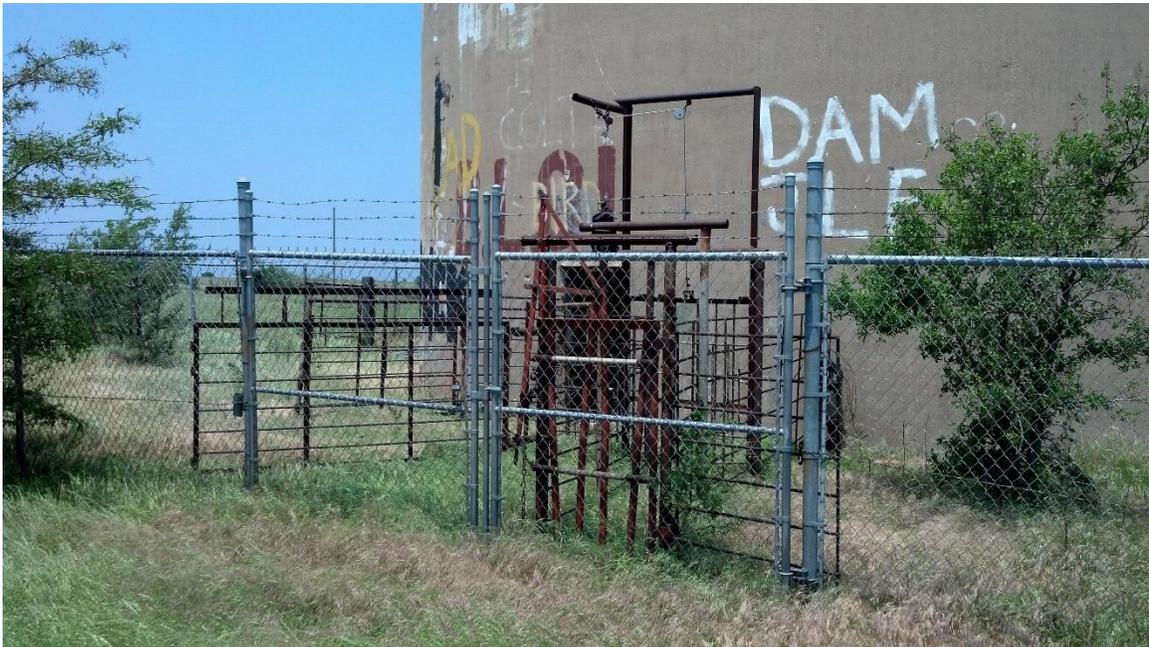
Figure 104 - Graffiti on the Exterior of a Base Water Tower Converted into a Cattle Corral
